Toronto, Ontario Canada  
March 29 – April 3, 2009

### Paper D-1-01

## TRENCHLESS REHABILITATION OF A TRENCHLESS INSTALLATION

Laura Wetter<sup>1</sup>, Kimberlie Staheli<sup>1</sup>, and Phil Cohen<sup>2</sup>

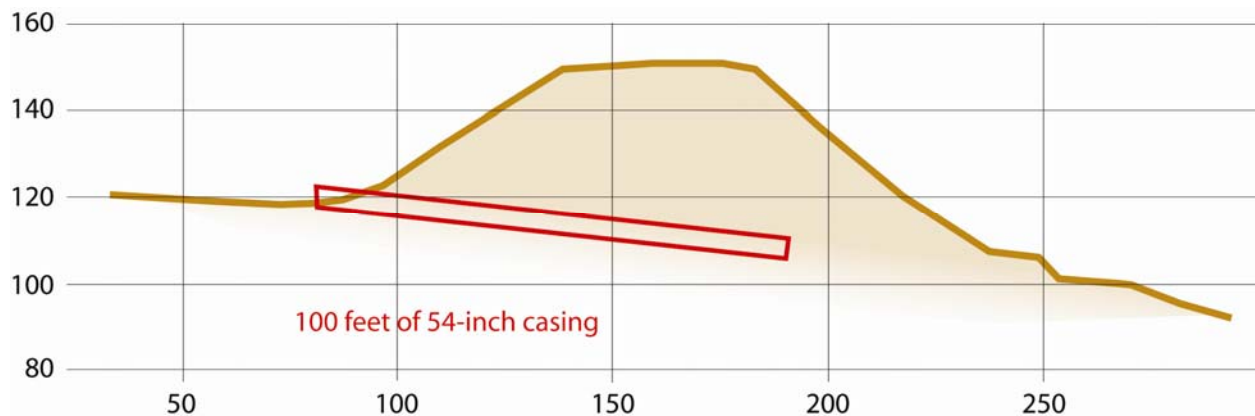
**Figure 2: Profile view after the first installation attempt**

After roughly 100 linear feet (LF) of the casing had been installed, soil and groundwater began to flow into the casing presumably at the contact between the lower fill unit and the native soil. Soil and groundwater ran into the casing, resulting in the formation of a significant sinkhole on the shoulder of Saratoga Road above the culvert. Following formation of the sinkhole, the casing was subsequently abandoned in place and the project as designed was terminated (Figure 2). A dewatering well was placed near the opening of the partially installed casing to prevent surface water from entering the pipe or flowing within the soil backfill around the existing culvert.

After roughly 100 linear feet (LF) of the casing had been installed, soil and groundwater began to flow into the casing presumably at the contact between the lower fill unit and the native soil.

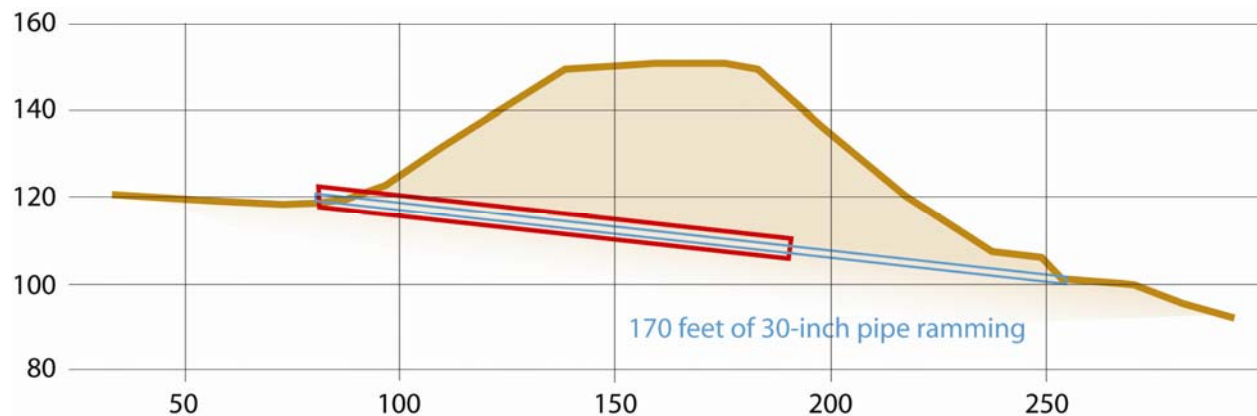
Figure 3: Profile view of design modifications

Ramming the existing 54-inch casing would have taken advantage of the pipe which had already been installed and in which the soil plug had already reached equilibrium. However, the existing casing was found to have a ½ inch wall thickness, which was not considered sufficient to withstand the ramming forces that would be required to move a large diameter casing which had been stationary for several months. Using the 54-inch casing to conduct a smaller casing would negate this risk, as a smaller casing would not require an increased wall thickness, and would utilize a new cutting shoe. Additionally, the smaller casing was expected to displace less soil than the 54-inch casing at the exit location, where the steep slope of the ravine is at high risk of land-sliding.

Subsequent hydraulic investigations by Island County Public Works selected a final culvert diameter of 24 inches, performed after the creek classification had been downgraded from fish-bearing. The final design consisted of the 24-inch diameter HDPE liner conducted by a 30-inch steel casing installed via open-ended pipe ramming (Figure 3).

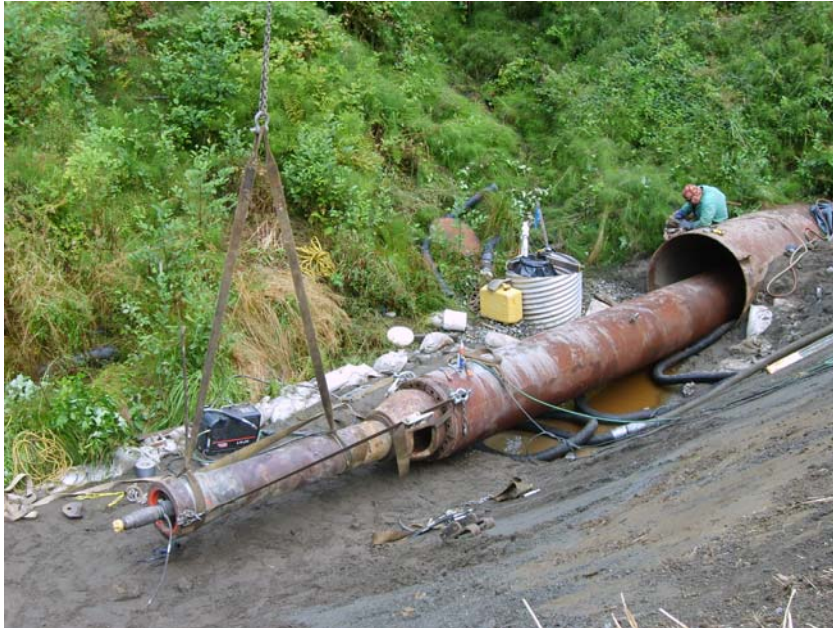
**Figure 4: The Grundoram hammer ready to ram**

inch casing through the soil plug using horizontal impacts by the excavator bucket, leaving approximately 20 feet of casing exposed at the entry point. After checking line and grade, the ramming tool was attached to the end of the 30-inch casing using an adapter, and ramming commenced (Figure 4).

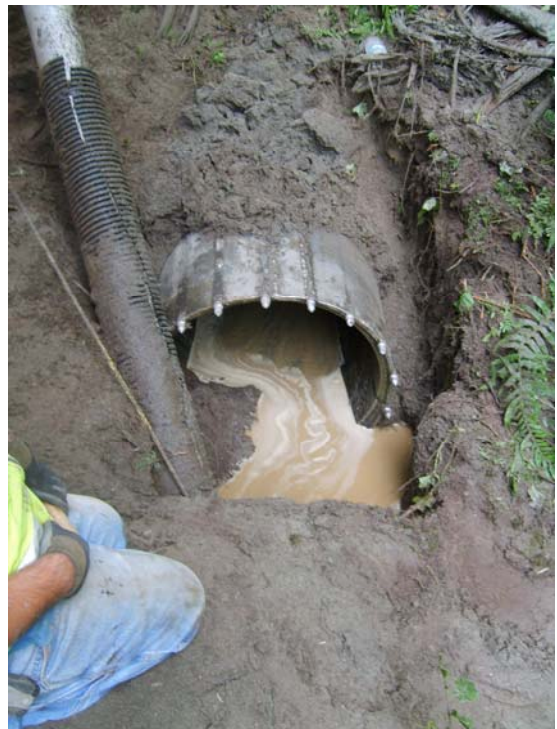
After inspection by the owner, it was decided that the 30-inch casing would be rammed 16 more feet to more fully bridge the distance between the casing and the bypassed creek. Advancement of the casing was performed without incident. However, after completion of the ram, cracks displacing up to 5mm were observed on Saratoga Road directly above the alignment.

**Figure 5: Daylight of the 30-inch casing. The bullet teeth can be seen around the edge of the cutting shoe.**
