SPENDING DIMES TO SAVE DOLLARS: THE VALUE OF SPECIALIZED CONSTRUCTION MANAGEMENT ON LARGE TRENCHLESS PROJECTS.

Kimberlie Staheli, P.E.¹, Matthew Wallin, P.E.²

¹ **Bennett/Staheli Engineers, Seattle, WA,**

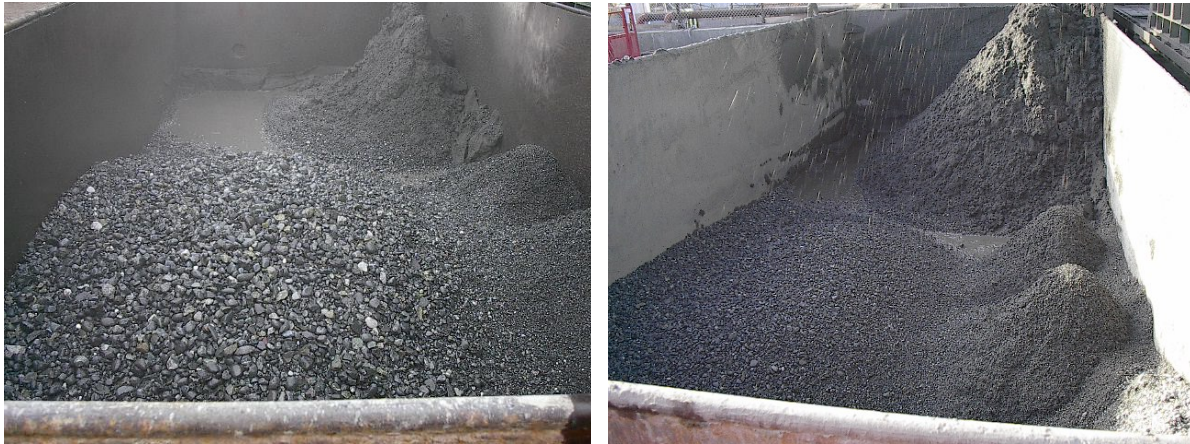
Interestingly, the Contractor claimed that the zone in which the DSC existed was within the last 200 feet of the drive; however, the construction inspector noted a distinct change in soil conditions at 82 feet from the reception shaft where gravel was no longer present in the formation. This note was further substantiated by construction photos of the soil separation plant and spoil bin taken during tunneling as shown in Figure 1

Figure 1 Spoil Bin with Significant Gravel (left) Spoil Transitioning to Fine Sand and Silt without Gravel (right)

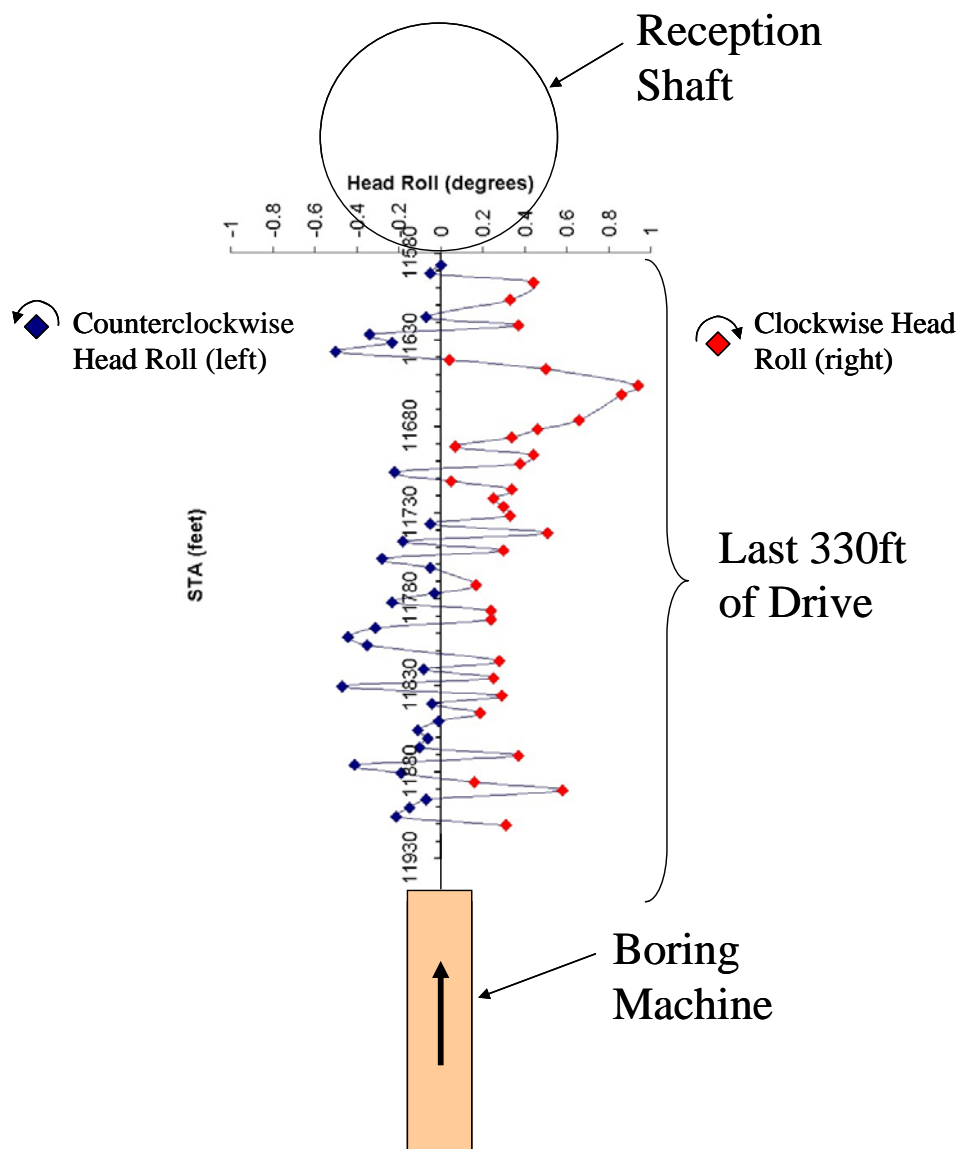
Figure 2 Cutterhead roll over the last 330 feet of the microtunnel drive.

Figure 2 clearly shows alternating head roll of the machine during the last 330 feet of the drive, consistent with operator induced cutterhead rotation reversals. For example, at STA 117+64, the machine displayed a negative (counterclockwise) head roll. Over the next five (5) feet of drive distance the cutterhead was rotated in the opposite direction and the machine responded by rolling clockwise until a positive (clockwise) head roll was indicated. Then, over the next five (5) feet of drive distance, the cutterhead rotation was again reversed and the machine rolled counterclockwise until a negative (counterclockwise) head roll was indicated. The information collected by the on-site construction inspector clearly showed that the machine roll data did not support the DSC claim of a loose soil condition over the last 200 feet of the drive.

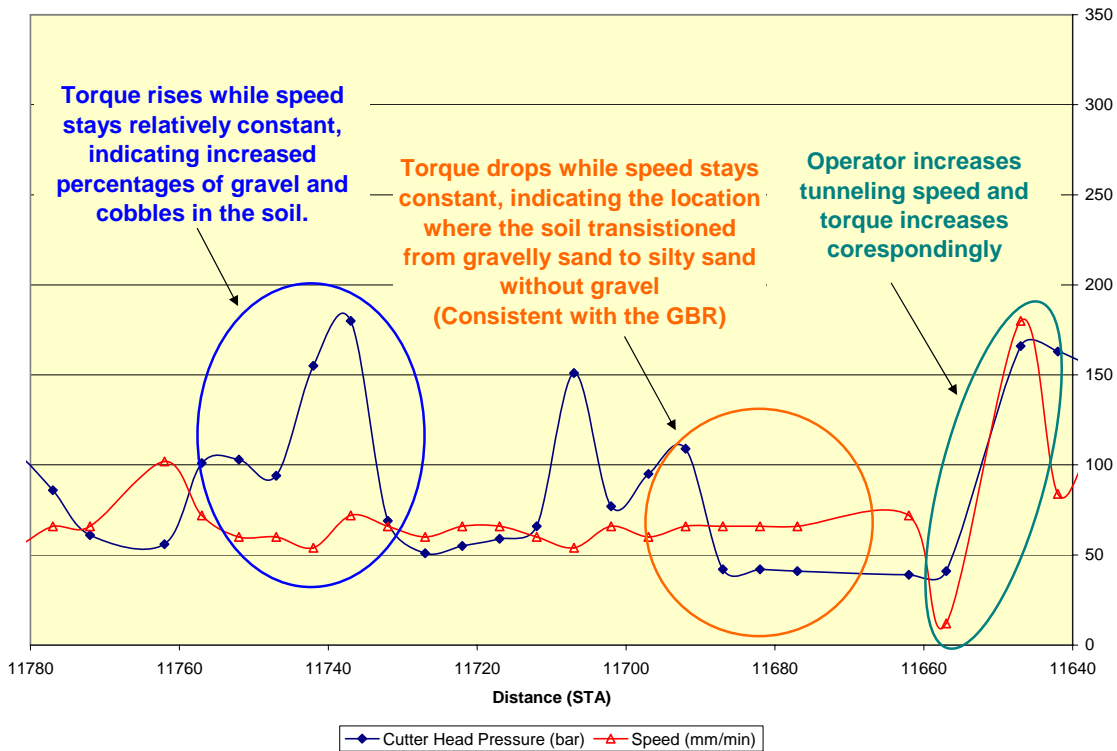
Figure 3 Annotated Torque Graph showing last 140 feet of Microtunnel Drive

In fact, at STA 117+64 the torque was increasing while the speed was remaining relatively constant. Between STA 117+32 and STA 116+86 the torque alternated between high and low as the MTBM most likely passed through a transitional zone of some gravelly soil and some sandy soil. At STA 116+86 the torque did drop rapidly; however, this location corresponds to the contact where the MTBM proceeded into uniform silty sand without gravel. This contact where gravel was no longer encountered corresponds with the description of soils presented in the GBR and the soil samples collected by the on-site inspector. As the machine passed from the gravelly soil, where it was required to crush rock to make progress, into a soil where no crushing was necessary, the torque would be expected to drop, especially if the operator did not increase speed. This reduction in torque is clearly illustrated in the Figure 3.. Then at STA 116+57 the speed was markedly increased to 180 mm/min and the torque increased correspondingly.

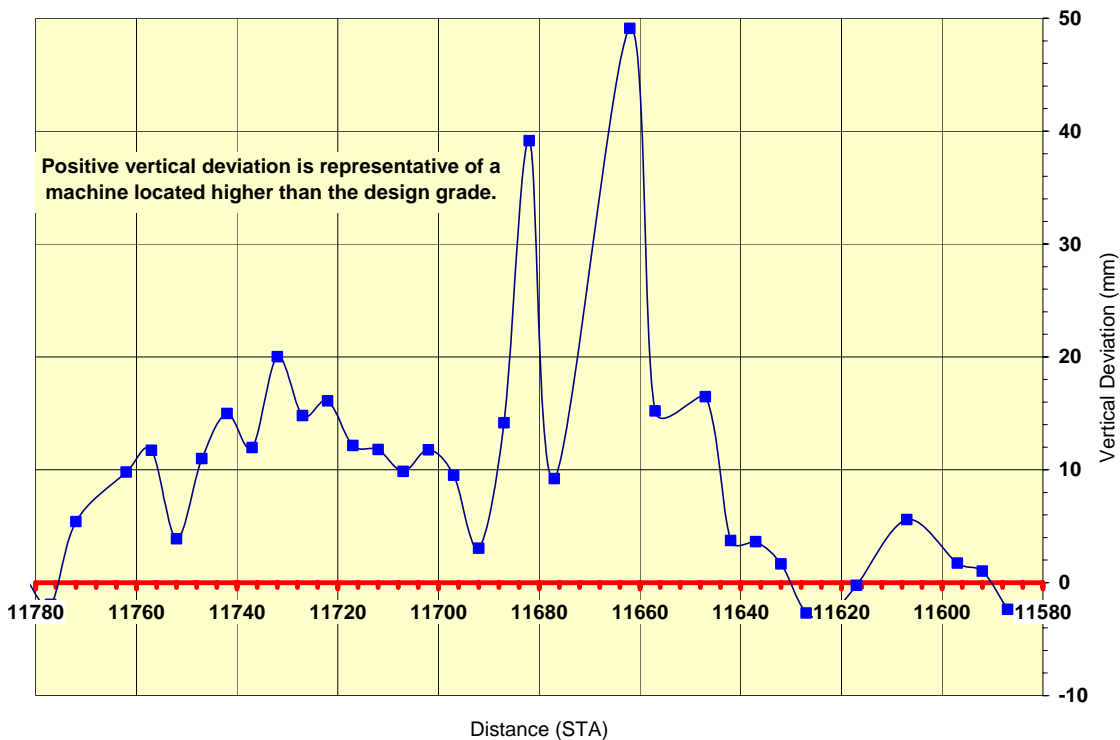
Figure 4 is a graph of the torque readings throughout the distance of the alleged DSC (the last 200 feet of the drive). It is important to note that the torque readings remained relatively high from STA 116+57 to the end of the drive. Had the soil conditions been very loose as the Contractor contended, the torque readings would have fallen and the operator would not have been able to sustain the high torque , even with marked increases in speed. The torque readings across the last 200 feet of the drive clearly indicate that the soil was not very loose as stated by the Contractor.

Figure 5 Vertical deviations of the microtunneling machine over last 200 feet.

The ability to steer the machine in a saw toothed pattern, as shown in this graph of vertical deviation clearly indicates that the soil encountered was dense. If very loose soils were actually encountered, these directional changes would not have occurred and the graph would show no sharp or abrupt reversals in direction. Hence, the physical evidence does not support the argument presented by the Contractor that the soil encountered between STA 117+64 and 115+81 was very loose.
