North American Society for Trenchless Technology (NASTT)
No-Dig Show 2012

Paper A-1-01

**DIRECTIONAL DRILLING IN MUKILTEO – LESSONS LEARNED FROM AN HDD WITH
330 FEET OF ELEVATION DIFFERENCE**

Matthew Pease¹, Laura Wetter¹, Dan Hammer²

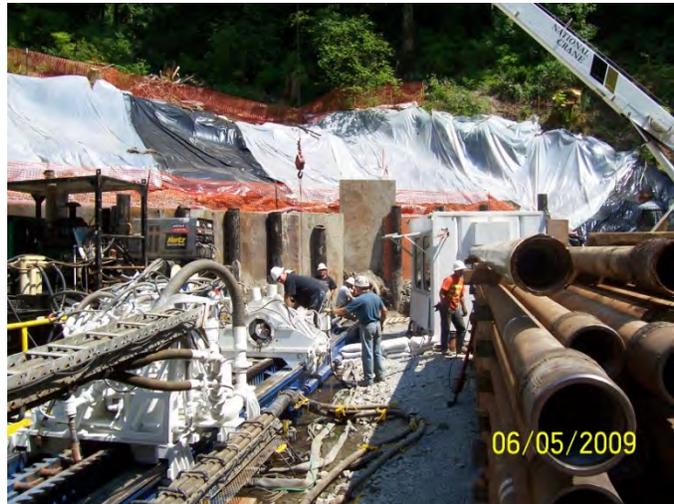
Figure 4: Temporary shoring at the entry location

In order to negate this risk, conductor casings were specified on both drills to bridge the bore into the more competent glacial lacustrine deposits. 80 and 100 feet of 36-inch and 20-inch conductor casings were specified for the trunk and lateral sewers, respectively. -Additionally, temporary shoring piles and steel plates were used to stabilize the slope at the HDD entry points in order to restrict potential movement of the slope toe while expanding the available contractor work area (Figure 4).

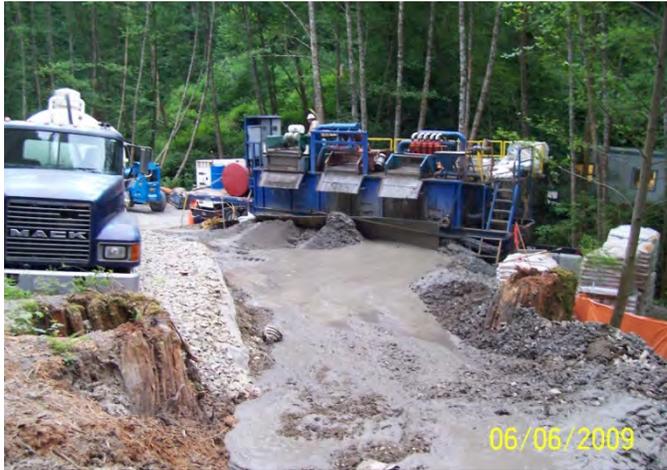
excessive volumes of spoils coming out of the mud pit began to clog the screens on the slurry plant and to overtop the spoil containment area beyond the defined boundaries of the construction work limits adjacent to a creek. (Figure 5). Repeated attempts to remove the drill string and re-drill the hole resulted in higher

Figure 5: Excess mud flows out of the spoils pit

and higher mud volumes coming out of the mud pit, and significant flooding of the work area with mud and spoils. Despite these complications, the Contractor elected to keep trying to advance the bore beyond the 310-foot mark using the original mud motor. Within the first eight days, the Contractor had re-drilled the same ~120 foot section of the alignment 12 times and had excavated several times the anticipated soil volume of the bore.

This continued over-excitation had a dramatic impact on the ninth day as three trees suddenly fell into a large sinkhole that developed on the surface more than 50 feet above the alignment.

At this point, the Contractor elected to switch

to a more traditional slanted head bit, with which 1,160 feet of the pilot bore was successfully drilled. Hard ground prompted the Contractor to switch to a different mud motor after 3 days of progress. One with less volume output was selected in order to restrict mud flow. After a few episodes of tripping and re-drilling, the Contractor successfully finished the 2,600-foot pilot bore after a combined 14 days of drilling.

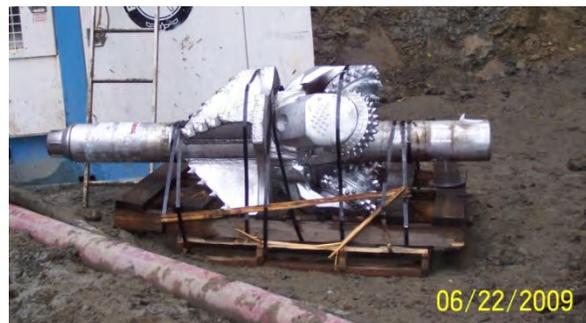
Reaming started in the third week of June with a 31-inch forward reamer (Figure 6). A problem was encountered almost immediately when the Contractor could not advance the reamer beyond the edge of the 36-inch conductor casing. It seemed probable that the edge of the casing had partially collapsed upon installation due to the repeated blows with the pneumatic ramming hammer. A crew member was sent into the 36-inch casing with a cutting torch to remove a portion of the collapsed section, and returned with a 1 foot by 1 foot section of the leading edge. At this point the Contractor was successful at advancing the reamer past the end of the conductor casing.

Figure 6: 31-inch forward reamer

However, once free of the casing, the reamer still had significant difficulty in advancing due to the near continuous collapse of the borehole, presumably through the section that had been significantly over-excavated during the pilot bore. The Contractor elected to advance a 12-inch washover casing behind the 31-inch reamer to maintain stability of the hole through this section, ultimately chasing approximately 250 feet of the reamed bore with washover casing. However, poor circulation and continued loss of mud into the formation led to an attempt to clean out the 12-inch casing. Insertion of an extra section of drill pipe succeeded in removing the “plug,” at which point a tremendous amount of drilling mud rushed out the end of the 36-inch casing and flooded the working area. Visual inspection of the hillside above the bore after the dramatic mud release showed that the existing sinkhole continued to increase in size and that surrounding trees appeared to be sinking as well.
