Chicago, Illinois
May 2-7, 2010

Paper A-1-04

OCEAN OUTFALL PRESENTS CHALLENGES TO HDD CONSTRUCTION

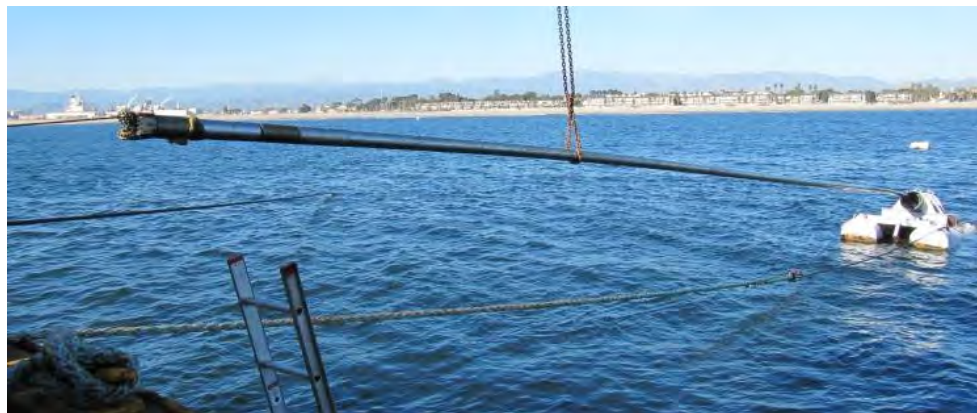
Initially the drill bit was exiting the water at about a 30 degree angle, which was too steep to secure to the deck without damage to the pipe. The crew was able to reposition the rigging supporting the drill string farther back down the pipe to

Figure 7. Drill string suspended between derrick barge and pontoon

improve the exit angle, and managed to get the borehole assembly secured to the deck of the barge where it was removed from the drill string.

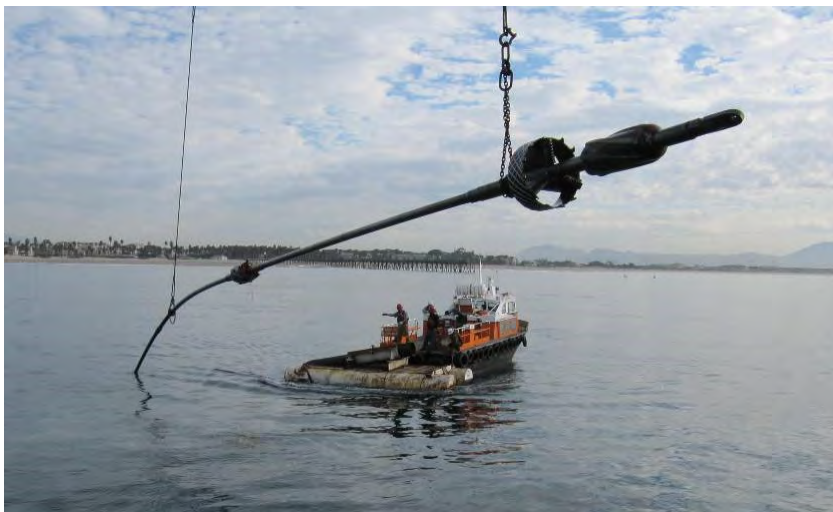
Figure 9. 48-inch reaming assembly exiting to the derrick barge

After the multiple failed attempts at the larger diameter, the Contractor elected to try forward reaming a 32-inch fly cutter, this time successfully completing the ream to the exit pit with adequate slurry returns and low rotary torque throughout. After removal onto the deck of the derrick barge, the 32-inch reamer was broken off the drill string and replaced with a new reaming assembly consisting of a 48-inch fly cutter, 29-inch centralizer and 36-inch barrel reamer. The back ream began at the exit pit with DP #75 and advanced all the way to DP #31 with no slurry returns observed at the entry. At this point reaming was considered

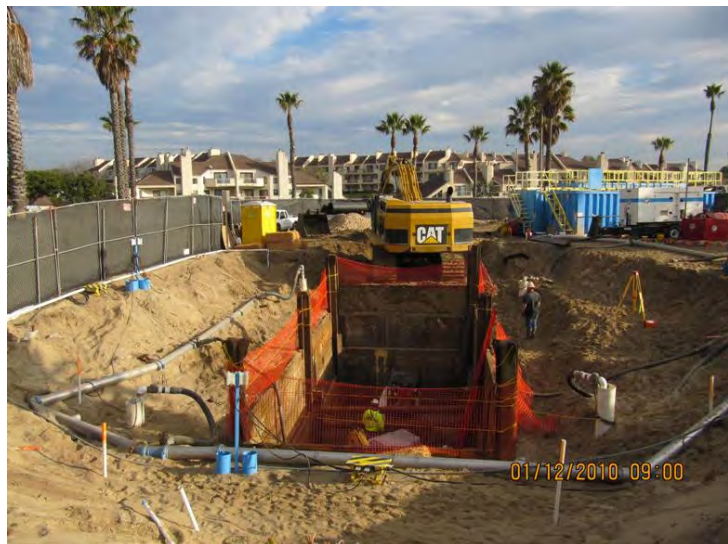
Pullback proceeded smoothly up until DP #4 at the end of the 54-inch conductor casing. The drill string was pushed forward and backward in an attempt to work the swab barrel through the end of the casing but was met without success for over two hours. Pull forces were so high that the supports between the rig and the casing sheared off and the rig moved several feet toward the entry pit. The Contractor tried inserting 100 feet of 18-inch centralizer casing in an attempt to centralize the barrel within the 54-inch casing, but with no effect. Pullback was halted on November 18th with the pull head within 90 feet of the entry pit.

However, once the pull head was exposed it was discovered that the pipe was too far out of alignment to be connected within the excavation at the end of the conductor casing. The last 90 feet of 36-inch diameter HDPE product pipe was eventually installed via open cut in February of 2010.

Figure 11. Excavation to expose pull head

After considerable discussion with the Owner, the Contractor exposed the pull head and swivel inside a slide rail shoring excavation at the end of the conductor casing (Figure 11).
