Washington, D.C.  
March 27-31, 2011

**Paper E-2-02**

**CONSTRUCTION OF THE BALCH CONSOLIDATION CONDUIT— SUCCESSFUL  
MICROTUNNELING IN VERY CHALLENGING SOIL CONDITIONS**

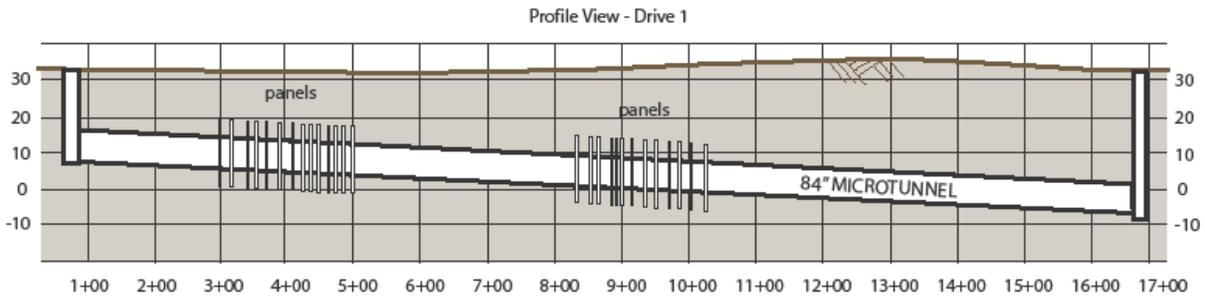
This is the first time that CSM panels have been used as ground support for microtunneling through soft soils. CSM panels were placed at the locations shown in Figure 4. Using the CSM panels significantly reduced the risk of damaging the fragile 54-inch sewer that ran parallel to the microtunnel drive because the installation method for the panels did not require the use of high pressure fluid injection.

Figure 3: CSM panel locations on the B to GLI alignment.

In concert with the design of the jet grouted columns, the Contractor had decided to build the microtunneling shafts with a cutter-soil-mixing (CSM) machine. The CSM machine constructs panels that are made of native soil mixed with bentonite and cement. Since the Contractor was going to have a CSM machine on site to construct the shafts, it was decided to use the CSM machine for ground modification, rather than the more common jet grouting technique.

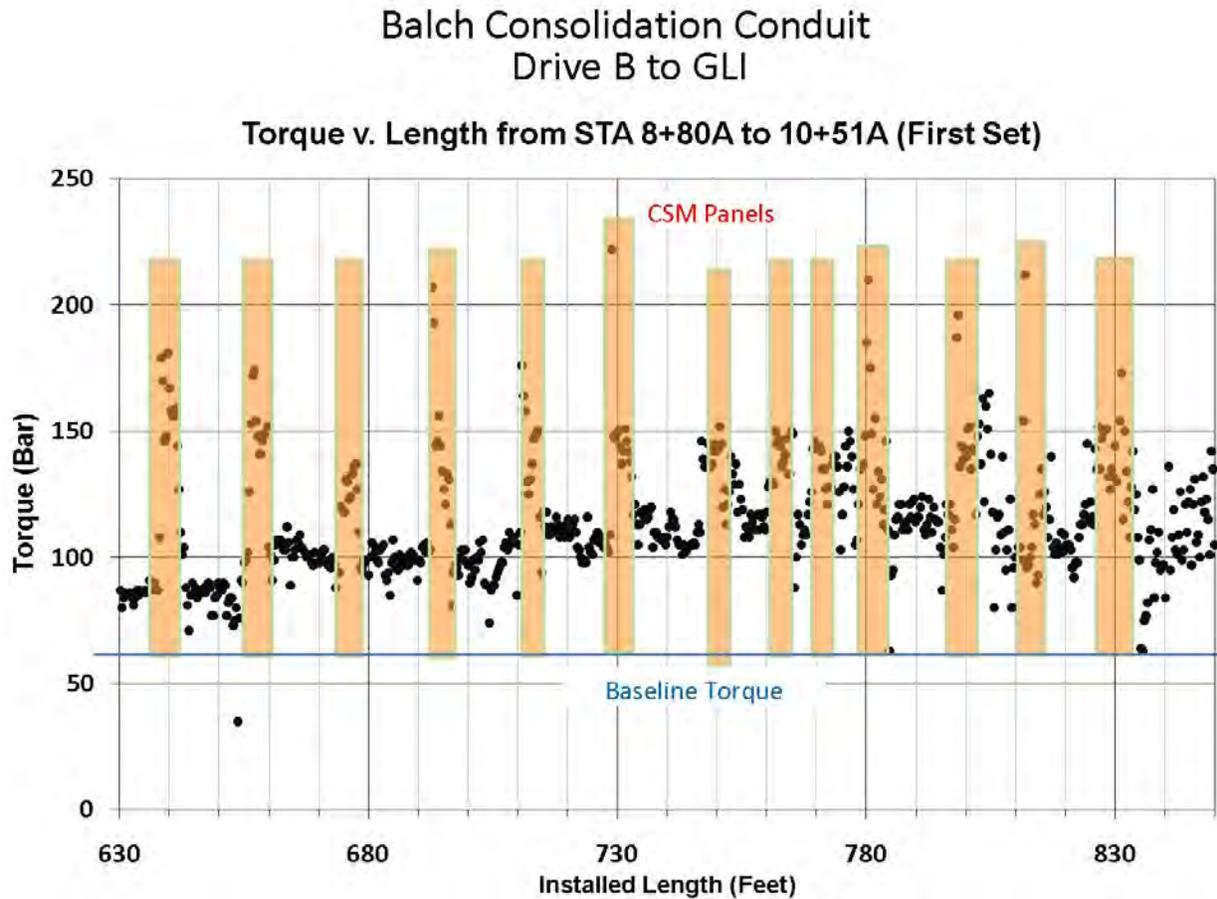
As the microtunneling machine entered into the very soft soils, the face pressure markedly dropped, which manifested as very low torque readings. However, it was obvious that when the machine progressed through the CSM panels, the torque readings and face pressure would increase. Figure 5 shows the torque readings on the machine as a function of drive length.

Figure 4. Torque vs. length (the locations of the CSM panels are shown).

The drive was successfully completed on line and grade because of the support provided by the CSM panels in the soft soils.

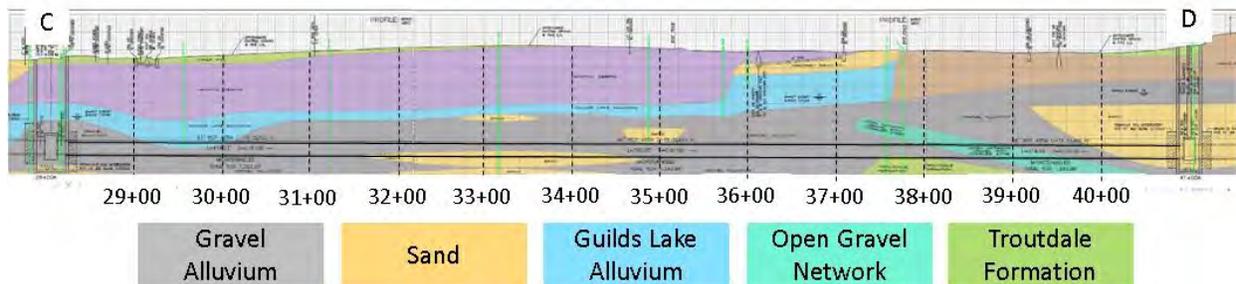
The microtunnel drive from C to D was 1,293 feet (394 m) in length and ranged in depth from 53 to 63 feet (16 to 19 m). The geotechnical conditions along the alignment were extremely complex and required numerous borings to characterize the soils at the depth of the alignment. Based on the geotechnical investigation, progressing from Shaft C to D, the microtunneling drive was expected to be within Gravel Alluvium for approximately 350 feet (107 m). The gravel within approximately 100 feet (30 m) of Shaft C was expected to contain significant fines. The drive was then expected to transition to a mixed face of Gravel Alluvium underlain by Sand for approximately 320 feet (98 m). The Sand was expected to be very dense but would exhibit flowing behavior due to the significant groundwater head to which it was exposed. The tunnel was then expected to transition back into full face Gravel Alluvium for approximately 260 (79 m) feet. The tunnel would then enter a zone approximately 80 feet (24 m) in length where the Troutdale Formation would be at the invert location. The tunnel would be in a mixed face of Gravel Alluvium underlain by Troutdale for approximately 120 feet (37 m). The Troutdale Formation in this area is gravel, cobbles, and boulders in a lightly cemented sandy silt formation. The tunnel would then transition into Open Network Gravel with Cobbles for approximately 120 feet. The tunnel would then transition back into Gravel Alluvium for approximately 60 feet (18 m) and terminate in 85 feet (26 m) of Sand. Figure 6 shows a profile of the expected geotechnical conditions.

Figure 6. Cross section of Drive C to D showing soil units by color.

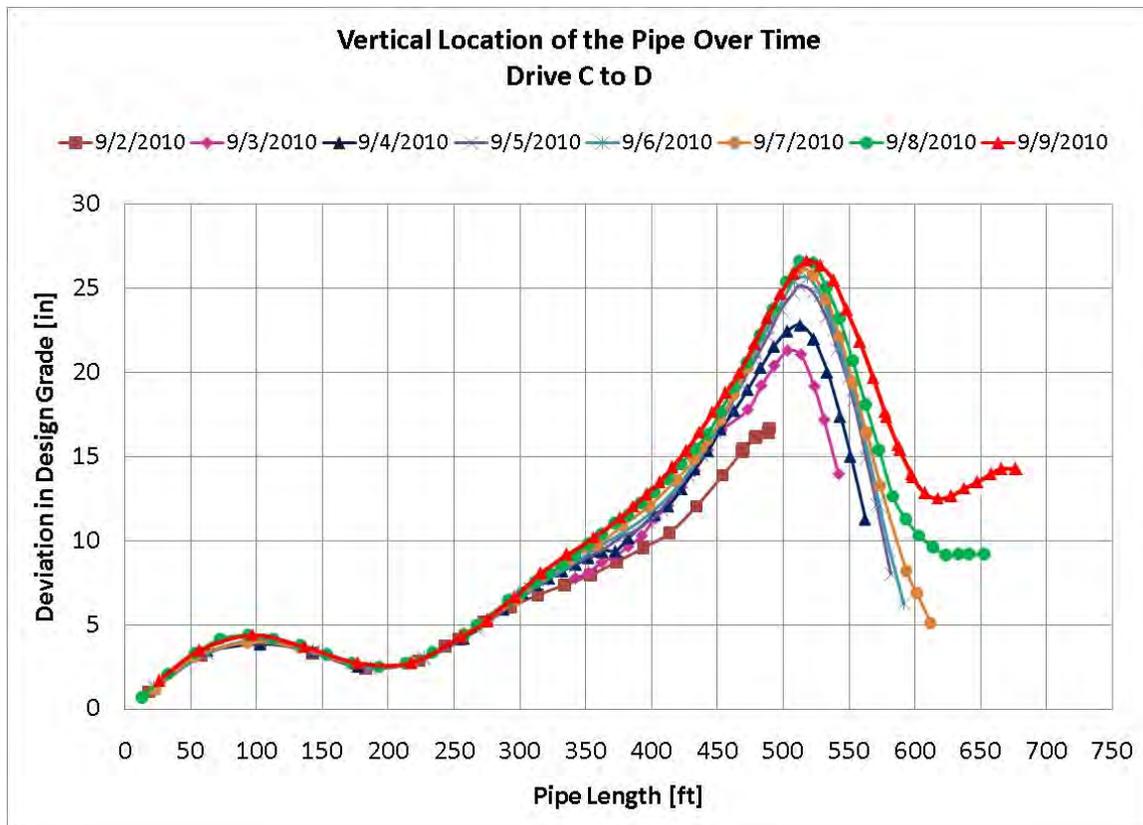
In addition, the “hump” that had been put into the pipeline after encountering the object was extremely sharp and stressed the pipe joints beyond a state of equilibrium. As a result, when jacking continued, the axial loads that were put into each joint across the “hump” were distributed through adjacent pipes, making the “hump” higher and wider with each push. Essentially, the pipe was moving both vertically and laterally in the ground to distribute the concentration of jacking forces through the pipe string. Figure 7 shows the as-built survey of the pipeline as it was taken after each 10-foot pipe (3 m) was jacked.

Figure 7. Length vs. deviation from design grade over time (9/2/2010 to 9/9/2010).

When looking at Figure 7, it is interesting to note that the object was encountered at 459 feet (140 m). As a result of encountering the object, the vertical deviation of the pipeline from design grade was approximately 14 inches (356 mm). Moving past the object, the machine “crested,” as if moving over a speed bump, resulting in a sharp curve in

the pipeline (as can be seen in Figure 7 on 9/3/2010). At that time, the deviation in grade had risen to 21 inches (533 mm). Each day a single 10-foot piece of pipe was jacked and a complete as-built survey of the pipe was conducted to record the location of the pipeline. Although the head of the machine and the first pipe section were trending back toward design line and grade, the remaining pipes continued to move vertically upward and toward the machine. This action distributed the jacking force more evenly throughout the “hump.” From September 2 to September 9, the crest of the vertical deviation of the pipe at 459 feet into the drive moved from 14 inches to 27 inches (356 to 686 mm). In addition, the peak of the “hump” in the pipeline shifted from 459 feet (140 m) in the drive to 518 feet (158 m).

With the alternative contracting mechanism, the Contractor, Engineer, and Owner were able to meet and discuss the options moving forward. Because of the efforts to get past the object, there was a significant “hump” in the pipe that was less than desirable for the gravity flow sewer. There was the option of digging up the machine because, by luck, the machine was not under a critical structure when the object was encountered. However, digging up the machine would cost over \$1 million and would have involved excavation through an abandoned landfill. BES ran hydraulic models and determined that the grade deviations in the system were not large enough to adversely impact the hydraulic conveyance requirements of the tunnel. As a result, it was decided to move forward with the microtunnel and try to drive the machine to a new design grade, as modified by the Engineer.

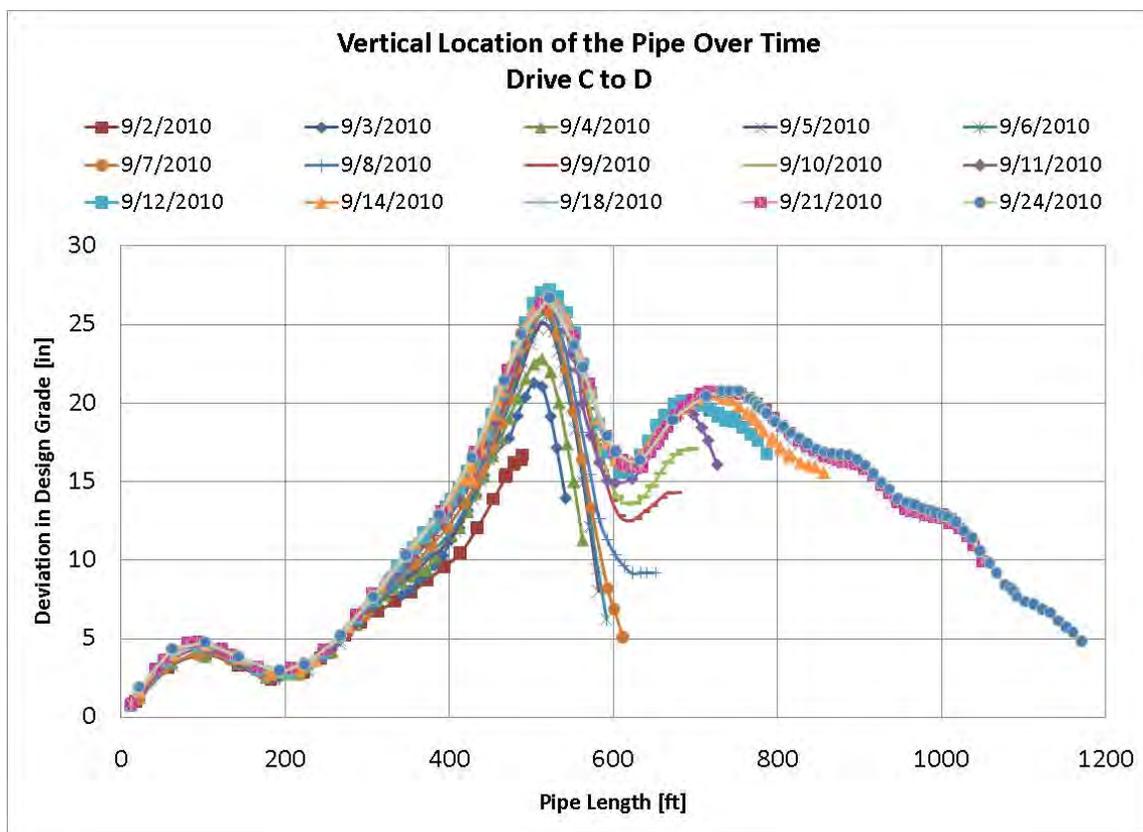
As the drive continued, the machine advanced with a negative pitch for approximately 600 feet (183 m). Although maximum steering inputs were applied to the machine in the lower steering cylinders, the machine would not respond, or would only respond very slightly, throughout the zone from 459 to 600 feet. However, at 600 feet the machine began to respond to the steering input. Due to the very aggressive steering input on the bottom steering cylinders, the machine immediately began to rise, resulting in counter steering. The result of this was a second “hump” in the alignment, as seen in Figure 8.

Figure 8. Length vs. deviation from design grade over time (9/2/2010 to 9/24/2010).

Perhaps the most interesting thing about Figure 8 is the documentation of the total amount that the pipe was able to move after installation. For example, at 600 feet (183 m) into the drive on September 7, 2010, the pipeline was only 5 inches (127 mm) out of vertical alignment but ended up being 16 inches (406 mm) out of vertical alignment. This vertical shift underground with approximately 60 feet (18 m) of earth cover on a 101.5-inch (2,578 mm) outer diameter concrete pipe is very rare and only happens in extremely unique circumstances..

One might assume that the soils in this region were very soft to allow the movement of the pipe; however, this was not the case. The pipe was moving under a tremendous amount of jacking force that was acting on an angle due to the misalignment of the pipes due to the vertical deviation. Figure 9 shows the jacking forces throughout the entire drive. It is easy to see that the jacking forces markedly increased when the object was encountered, and continued to

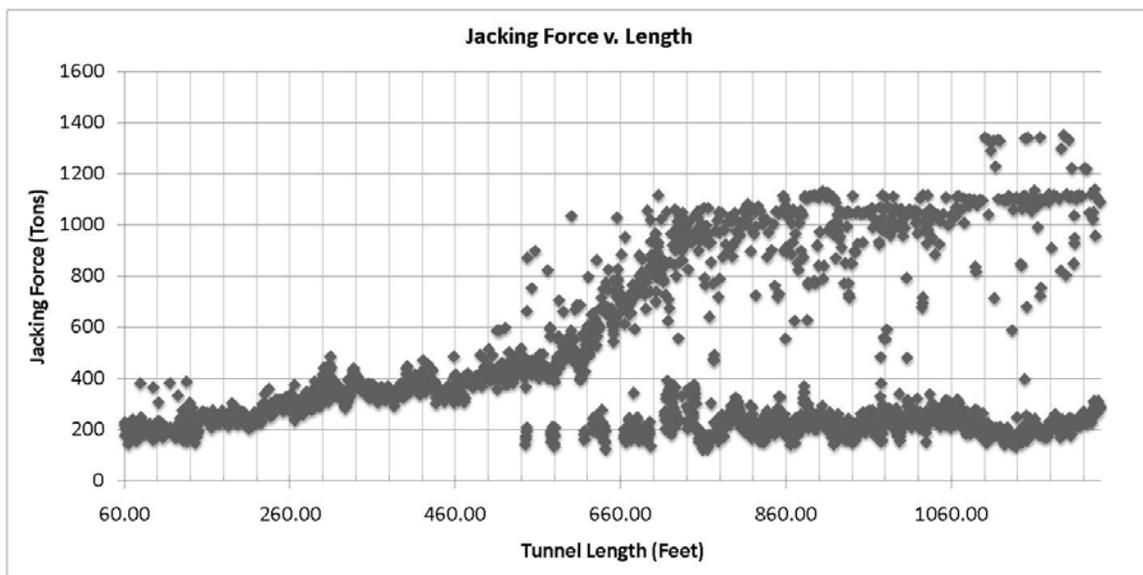
rise at an increased rate (as compared to before the object was encountered) until the machine was well beyond the alignment deviations. When examining Figure 9, one should note that the lower jacking forces (between 200 and 300 tons [181 and 282 tonnes]) that can be seen at the bottom of the graph from 500 feet (152 m) to the end of the drive are forces from the telescopic jacking station. This station was located just behind the head. When the object was encountered, the telescopic jacking station was used to push the head forward and to excavate. The main jacks and intermediate jacking stations were then used to propel the pipe forward.

When the pipe was being pushed over the main grade deviation area, it was necessary to use the intermediate jacking station because the main jack, at 1,200 tons (1,089 tonnes), did not have enough force to propel the entire pipe string. This is because a tremendous amount of the force was being used to move the pipeline vertically and horizontally toward the machine, rather than to propel the pipe along the design alignment. At times when the intermediate jacking station (IJS) was advancing over the first “hump,” the maximum extension on the IJS was 1 inch (25 mm) when the hydraulic cylinders were at the maximum pressure. At that point, there was much concern that the pipe was going to get stuck because of the excessive jacking thrust requirement.

Figure 9. Length vs. jacking forces for Drive C to D.

At the end of the drive, it can be seen that although the face pressure and excavation forces were eliminated from the total jacking force by independently using the telescopic station to excavate, jacking forces were still spiking at the main jacks at 1,380 tons (1,252 tonnes). This was right at the maximum force available from the jacking frame and beyond the design limit of the jacking shaft. However, the drive was completed successfully and close to the original construction budget.
