**North American Society for Trenchless Technology (NASTT)
NASTT's 2014 No-Dig Show**

MM-T5-02

**Salvaging the Lessons Learned from a
Difficult Microtunneling Project**

Kimberlie Staheli, Ph.D., P.E., Staheli Trenchless Consultants, Seattle, WA
Peter Robertson, Ph.D., P.E., Gregg Drilling and Testing, Huntington Beach, CA
Paul Vadnais, Vadnais Corporation, San Diego, CA
Dylan Davidson, Staheli Trenchless Consultants, Seattle, WA

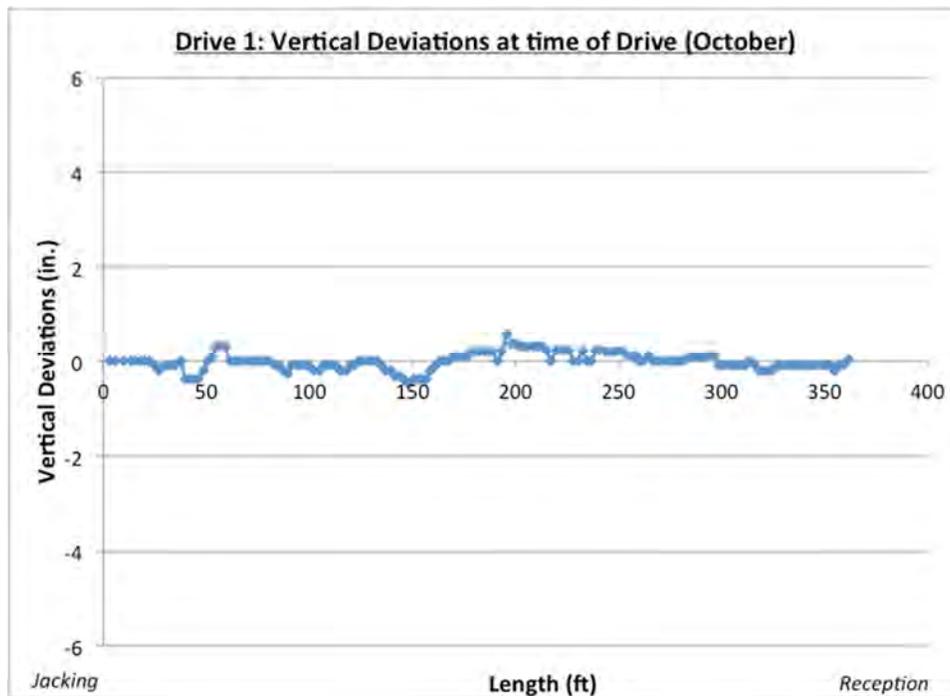
Drive 1 was constructed in the month of October, and the 391-foot drive was completed without issue. The drive record showed that the pipe was installed within ½ -inch of line and grade. Line and grade tolerance was specified as +/- 1-inch of line and grade so the drive was installed well within the required tolerance. The machine was retrieved within the lift station wet well. Figure 2 shows the position of the laser relative to the target within the 24-inch machine during construction of Drive 1.

Figure 2. Vertical deviations measured during Drive 1.

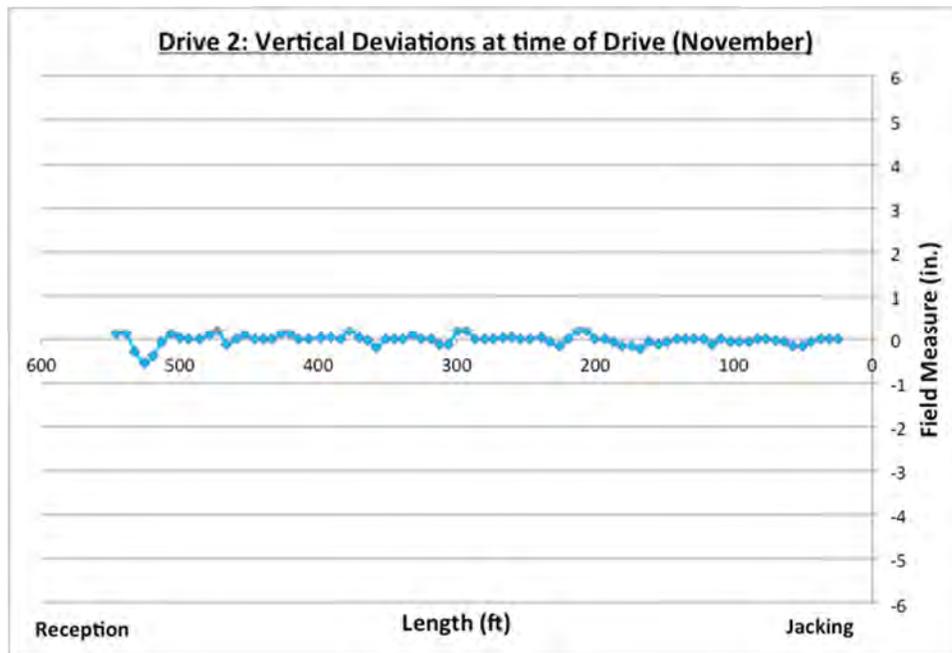
drive was completed within $\frac{1}{4}$ of an inch of the design line and grade. At one location the grade was $\frac{1}{2}$ -inch low, which was the largest deviation from line and grade on the entire drive. Figure 3 shows the location of the laser relative to the target located in the 24-inch microtunneling machine.

Figure 3. Vertical deviations measured during Drive 2.

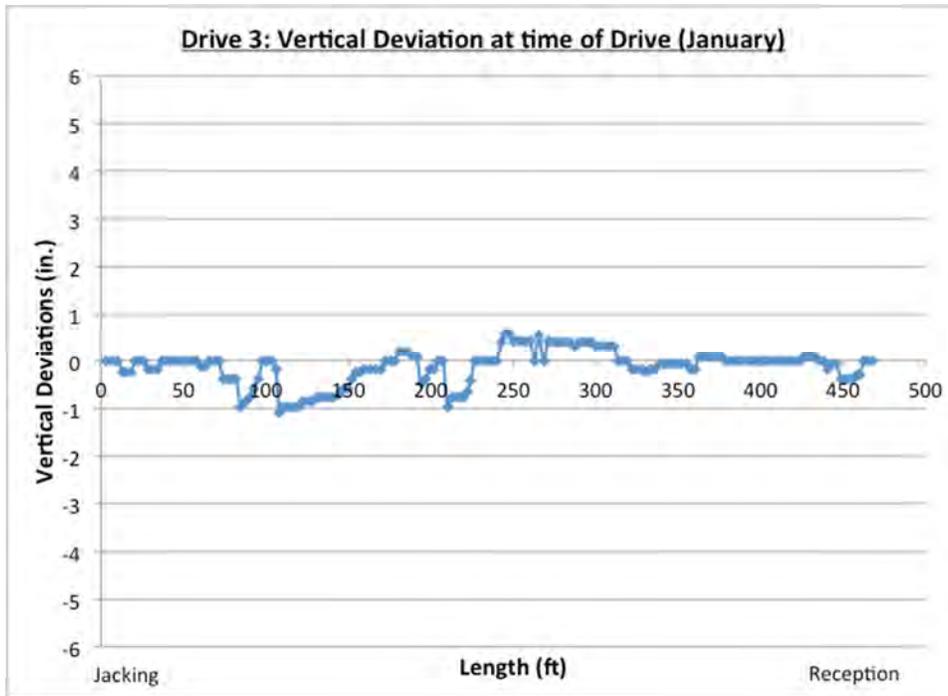
In January of the following year, the Contractor moved the microtunneling equipment to the next jacking shaft to begin Drive 3, a 444-foot drive towards Drive 2. During the drive, the operator noted grade deviations of up to one inch at 110 feet and 220 feet into the alignment and was forced to move the laser to keep the laser on the target within the 24-inch machine. While pushing within 50 tons of the safe jacking capacity of the pipe (calculated with a safety factor of 2.5), the pipe broke at 460 feet into the drive. The breakage of the pipe was significant and allowed water to flow within the pipe. This water flooded the machine and the shaft, causing numerous problems and a significant delay. The microtunnel machine required retrieval from the surface and Drive 3 had to be completed by open cut excavation. Figure 4 shows the location of the laser relative to the target in the 30-inch microtunneling machine prior to the time the pipe broke and the drive was abandoned.

Figure 4. Vertical deviations measured during Drive 3 prior to abandonment.

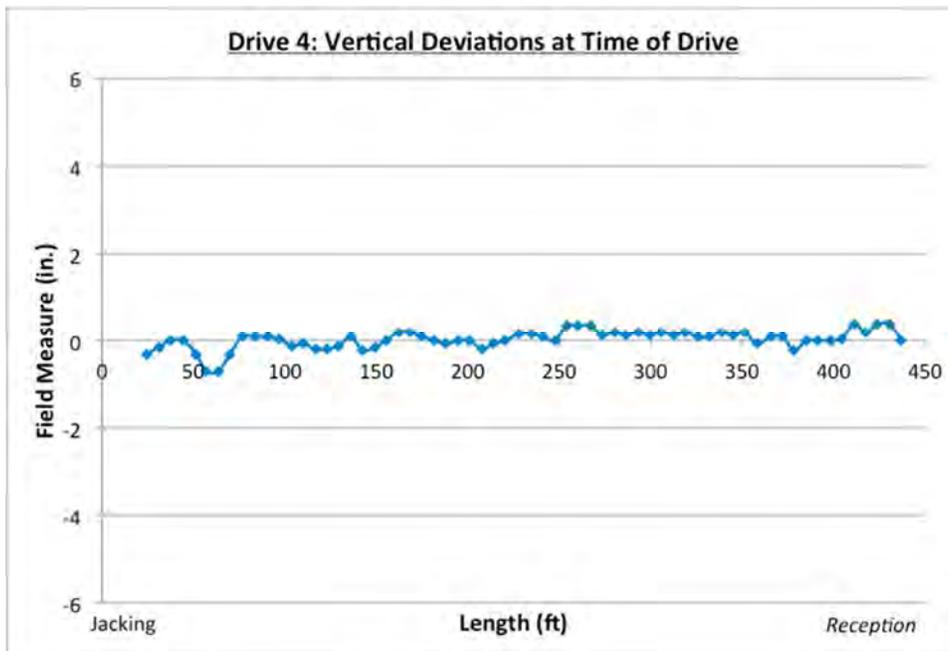
Drive 4 began in April, at which time the Contractor rotated the equipment in the shaft and began the 316-foot drive toward the Pacific Ocean. The drive was completed with little incident and was completed successfully with less than ½-inch deviation on line and grade. Figure 5 shows the location of the laser relative to the target within the 30-inch machine during the drive.

Figure 5. Vertical deviations measured during Drive 4.

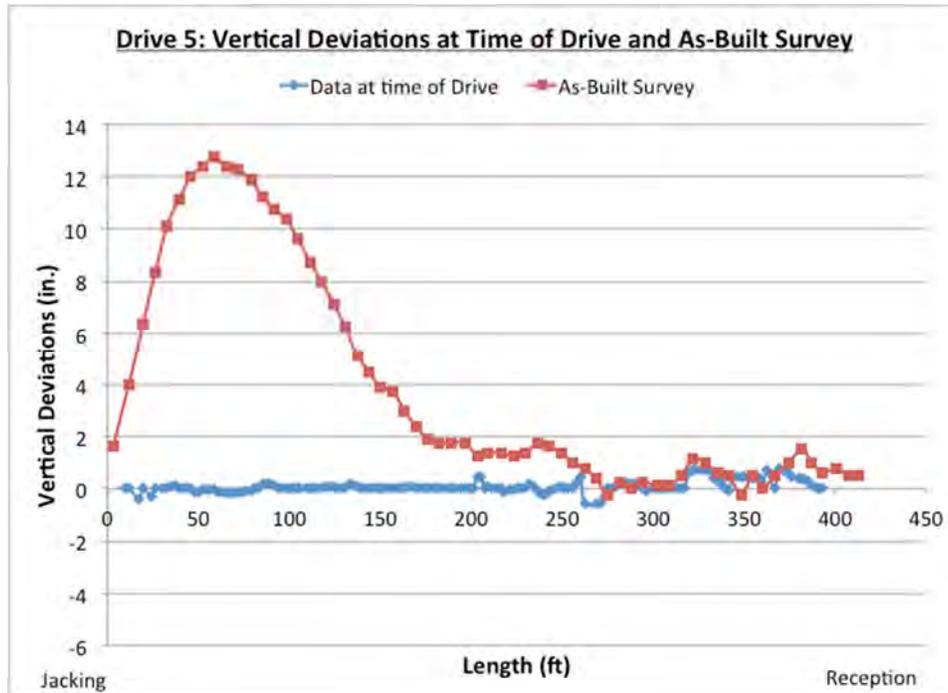
grade deviations in the pipe were noted at the pipes near the shaft. When these pipes were initially installed by the microtunnel machine, the microtunneling equipment guidance system showed that they were within the one inch line and grade tolerance; however, as the drive progressed, the pipes were beginning to increase in grade. This trend continued as the drive extended, as the pipes within 150 feet of the shaft rose upward and caused a hump in the pipe that deviated by as much as 13 inches from line and grade. The drive was finished with the machine at the appropriate line and grade; however, the 13-inch hump in the pipe was significant and would not allow the sewage to flow by gravity to the Lift Station. Figure 6 shows the grade deviations of the pipe as it was being constructed (i.e. the position of the laser relative to the machine target), along with the as-built survey of the pipe at the completion of the tunnel drive. It is important to note that by the end of the tunneling the operator was forced to move the laser to keep it on the target due to the large hump in the pipeline. These values were corrected on Figure 6 to reflect the actual position of the machine based on the operator's notes that kept track of the laser movement.

Figure 6. Vertical deviations measured during and post-construction of Drive 5.

It was unclear at this point why the pipe had risen during jacking as there was no indication of encountering an obstruction or any object that would have caused the machine to rise – in fact, the machine was on line and grade during the excavation of the first 275 feet. The rise in the pipe occurred after excavation, but the question was – why?

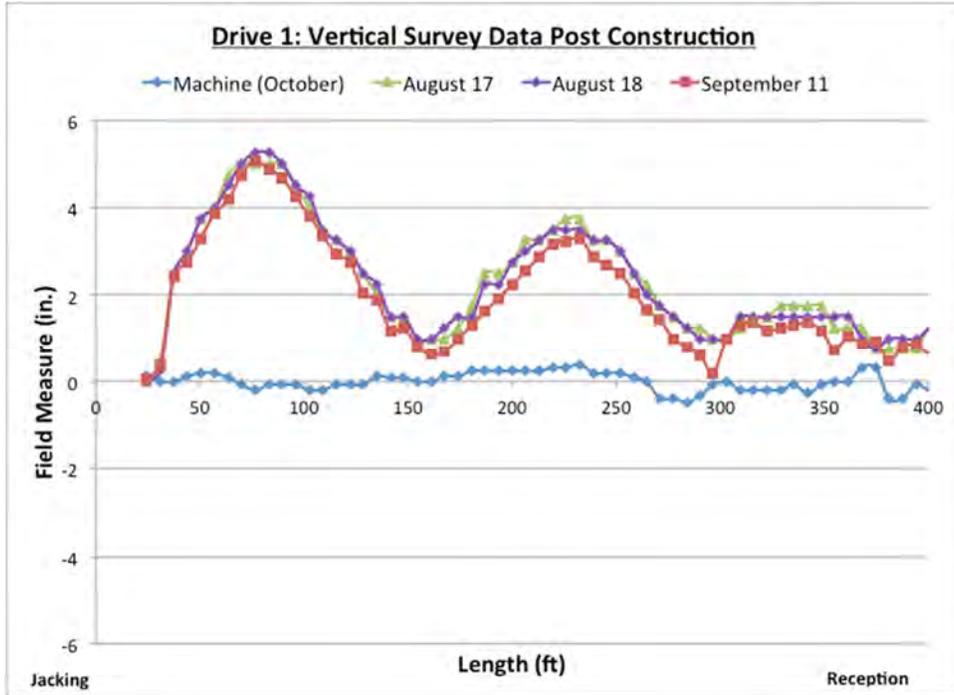
After the pipe on Drive 5 had risen, it was decided to go back and re-survey the other microtunnel drives (1 through 4) to determine their exact locations. The results of the surveys were astonishing. Drive 1, which had originally been installed within the specified line and grade tolerance at the time of construction, had shown significant movement. In fact, there were locations where the pipe exhibited humps that were five and four inches out of tolerance, as shown in Figure 7. With the tight grades specified on the project, the areas exhibiting the deviations were significant enough that they would require repair to allow the sewer to flow by gravity.

Figure 7. Vertical deviations measured during and post-construction of Drive 1.

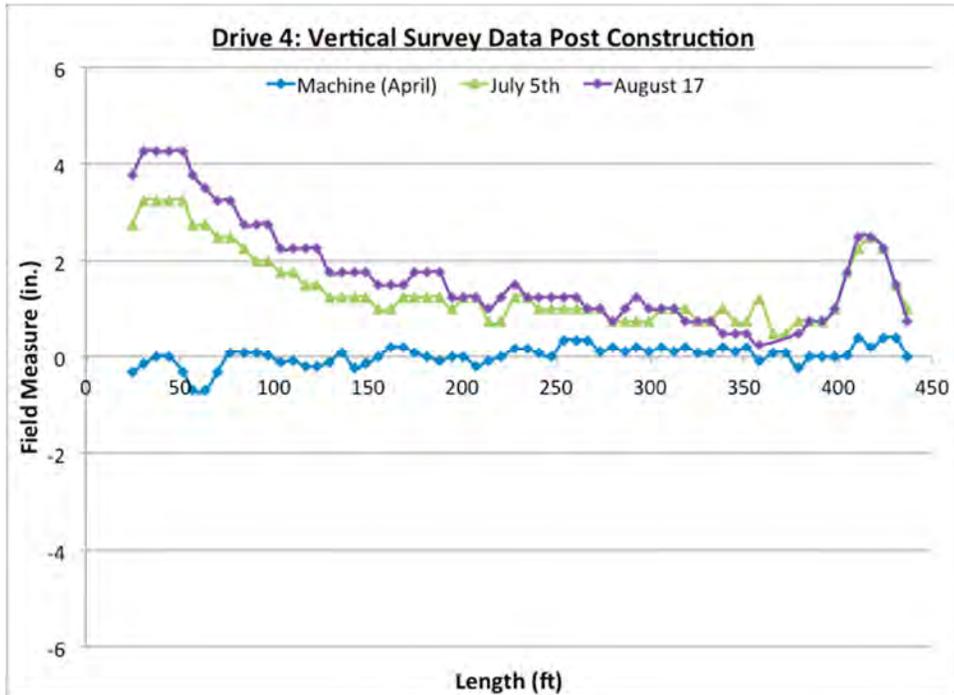
Drive 2 was re-surveyed but showed essentially no change in grade from the original installation to the re-survey. Drive 3 could not be surveyed because it contained the as-yet unfixed broken pipe, allowing water into the excavation and making entry unsafe. When Drive 4 was re-surveyed, significant deviations in line and grade appeared, even though it had been installed within line and grade tolerances only three months prior to the re-survey. Drive 4 showed grade deviations of four-inches and two and 1/2 - inches at the near-shaft locations, as shown in Figure 8.

Figure 8. Vertical deviations measured during and post-construction of Drive 4.

An examination of Drive 4 revealed that at the time of construction, the water in the primary aquifer was not pressurized, according to the County monitoring wells. However, within a month after construction, the primary aquifer became pressurized and some wells exhibited artesian pressures. Figure 8 showed that the flotation effects were the highest nearest the shaft locations. It was then determined that the shafts had breached the aquitard during construction and were not completely sealed at the interface, creating a pathway between the shallow and primary aquifers. Since the pipe was designed only a few feet beneath the aquitard, the critical gradient to cause piping of the sandy soils between the shallow and primary aquifer was very low. When the pressure in the primary aquifer began to rise above that in the shallow aquifer, the water began to migrate upwards into the shallow aquifer. Nearest the shafts where the aquitard had been breached, the movement of water took soil particles with it, removing the soil from above the pipeline. Since the pipe was buoyant, the pipe floated into the space that was vacated by the soil that had moved into the shallow aquifer due to soil piping. These effects were not seen on Drive 4 during construction because the primary aquifer was not pressurized at the time of construction.

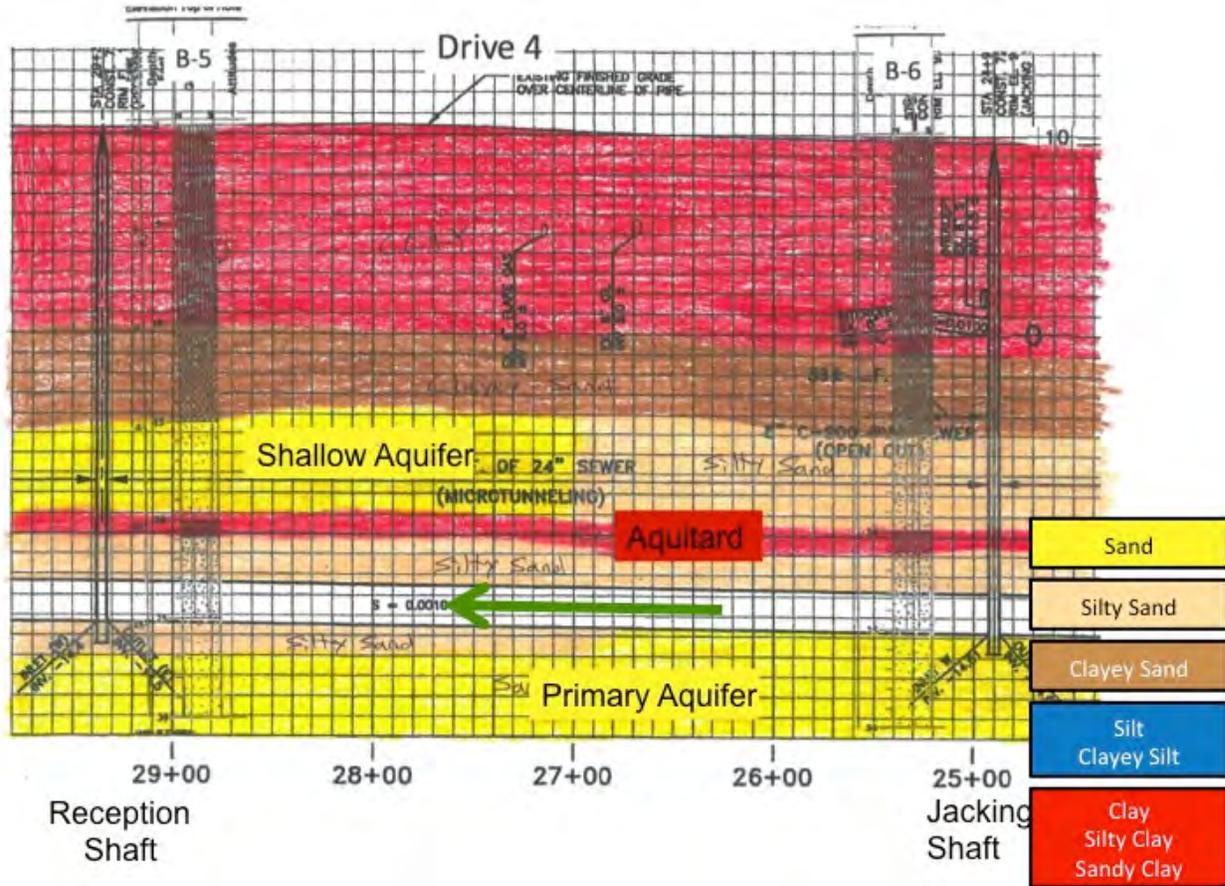
The geotechnical conditions at the site were analyzed to compare the flotation of the pipe with the locations of the aquifers and the records at the monitoring wells. The geotechnical conditions for Drive 4 are shown in Figure 9. The geotechnical conditions revealed that the microtunnel was designed just below an aquitard that separated the Shallow Aquifer System and the Primary Aquifer System.

Figure 9. Geotechnical Conditions along Drive 4 showing the Shallow and Primary Aquifer.

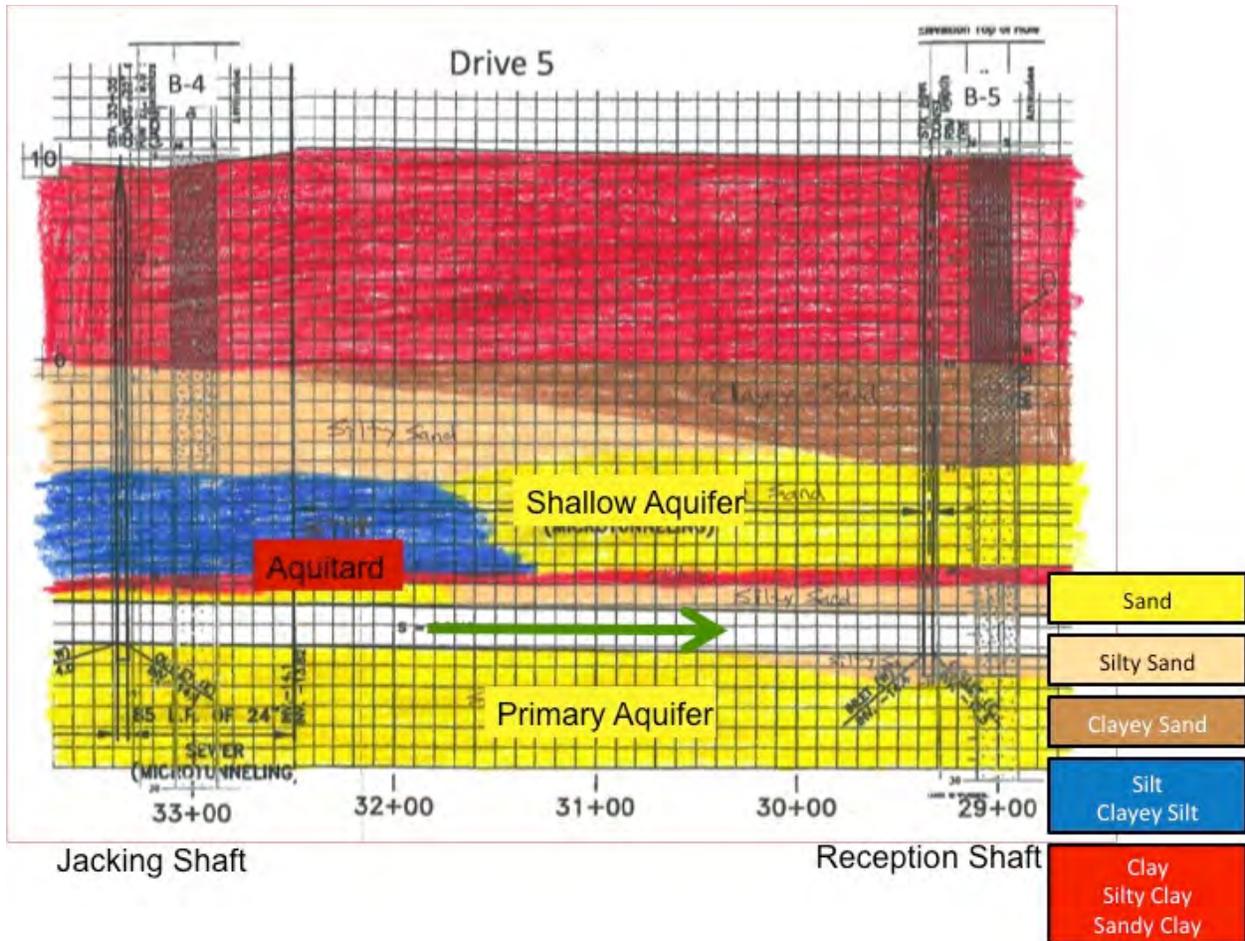
However, on Drive 5, the primary aquifer was pressurized during the time of construction. In fact, as they were microtunneling, the primary aquifer was pressurized to the point that the critical gradient was reached near the jacking shaft location. This caused the soil above the pipe to begin piping/moving above the aquitard (clay) layer during the installation of the pipe. Although the Contractor was installing the pipe to the design line and grade, the pipe began to float during the installation because of the pressure gradient between the Shallow and Primary Aquifers. Figure 10 shows the geotechnical conditions on Drive 5 during construction.

Figure 10. Geotechnical Conditions along Drive 5 showing the Shallow and Primary Aquifer.

Of note on Drive 5 was the fact that the aquitard is significantly thick in the area where the piping occurred, resulting in flotation of the pipe; however, beyond approximately 250 feet into the drive, the aquitard shrinks to less than 6 inches thick. In Boring B-5, the aquitard is seen only as a thin layer of clay, which has been interpreted to stretch along the drive. It is therefore possible that the aquitard is in fact discontinuous, allowing the pressures to equalize during tunneling, and eliminating the potential for pipe flotation in that area.

If pressurized water was known to exist at the site, it would have been critical to include a grouting program with the shaft design to completely seal the shafts so that no piping could have occurred at the location of the shafts. Alternatively, the pipeline could have been deepened below the aquitard so that the critical gradient was much higher and would not have been reached with the water pressure fluctuations that were expected in the local area.

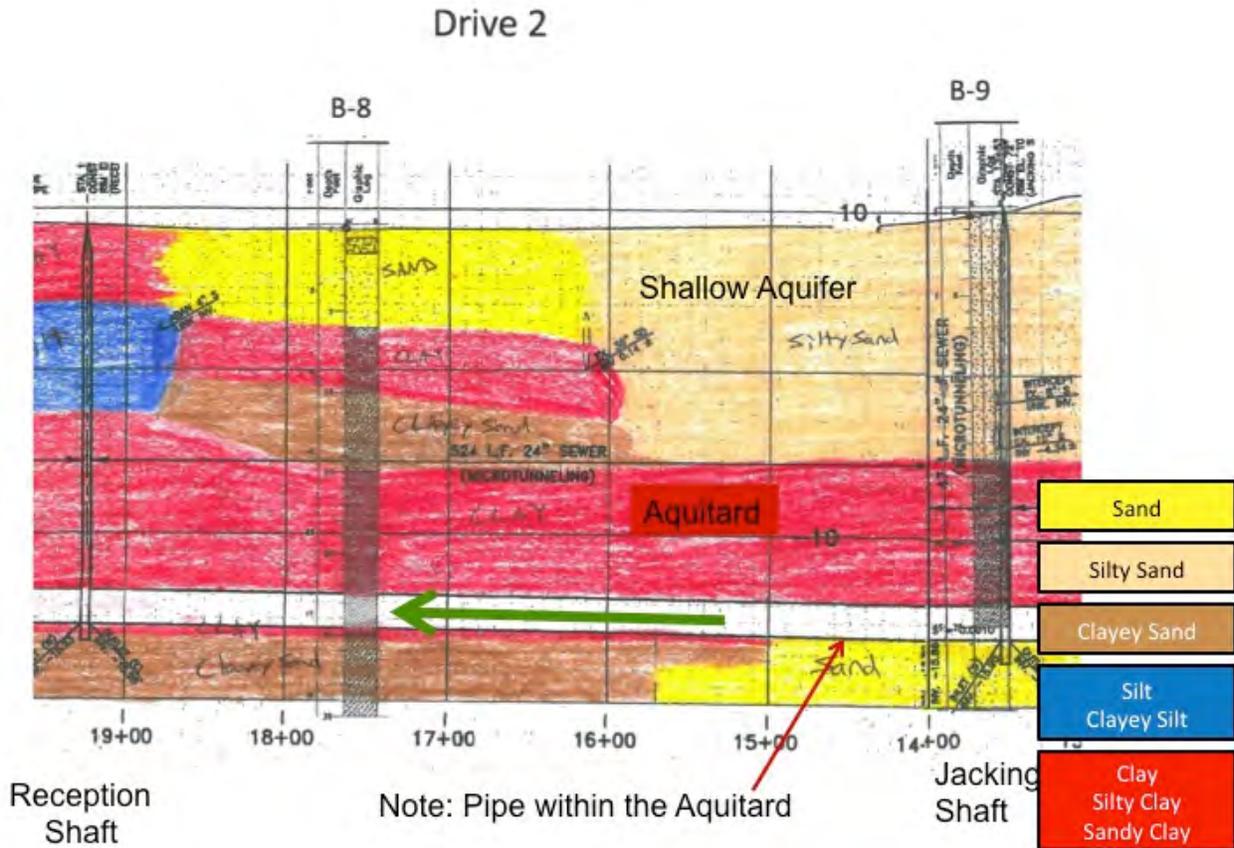
Drive 1 showed a similar pattern to Drives 4 and 5 with an aquitard within a few feet of the pipe, sandy soils above the pipe that were susceptible to piping, and flotation of the pipe near the shaft locations where the aquitard was breached by the shaft construction. However, of equal importance was Drive 2 where no flotation was observed during or post construction. The geotechnical conditions for Drive 2 are shown in Figure 11.

Figure 11. Geotechnical Conditions along Drive 2.

Drive 2 was constructed almost entirely within clay. At no point along the drive was there a condition where there was sand above the pipe as the alignment was completely within the clay aquitard. Because of this fact, there was no soil above the pipeline that was susceptible to piping. Although the primary aquifer became pressurized on this drive, as with all the other drives, piping of the soils did not occur as clay is not susceptible to piping under the pressure gradient that was measured in the monitoring wells. Therefore, there was no flotation of the pipeline. This proved to be the case as the post construction surveys revealed that no flotation had taken place on Drive 2 after the pressurization of the aquifers.
