**North American Society for Trenchless Technology (NASTT)
NASTT's 2016 No-Dig Show**

TM2-T4-02

Into the Void: Case Study of an Emergency Pipe Burst under the West Seattle Bridge

Matthew Olson, Staheli Trenchless Consultants, Lynnwood, WA
Cody Nelson, Seattle Public Utilities, Seattle, WA

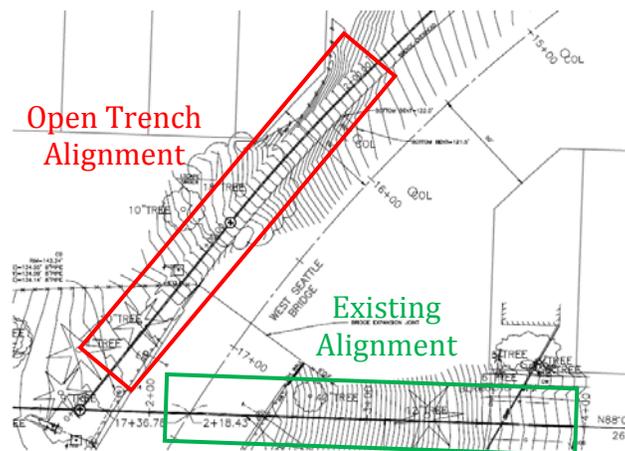
Figure 2. Open Trench Re-Route (Option One) – Plan View Snapshot.

Option One included installation of a new 8-inch pipeline and abandonment of the existing 8-inch VCP combined sewer. Figure 2 depicts a snapshot of the plan view of the open trench alignment. The new open trench pipeline would have intercepted flows from the existing system at a new MH installed on the west side of the WSB and would have discharged flows into the existing combined sewer at a new MH on SW Manning Street, to the north. The new pipeline would have traversed Seattle Department of Transportation (SDOT) right of way (ROW) between the connection points at depths below grade ranging from 7 to 19 feet. SDOT required the pipeline to be located 10 feet laterally from the WSB deck and foundation system. Private structures encroaching on SDOT ROW, left approximately 6 feet of working space along a portion of the proposed alignment, dubbed the “pinch point”. As such, Option One would have necessitated removal of a privately owned storage shed and fence, an option that was to be avoided if possible.

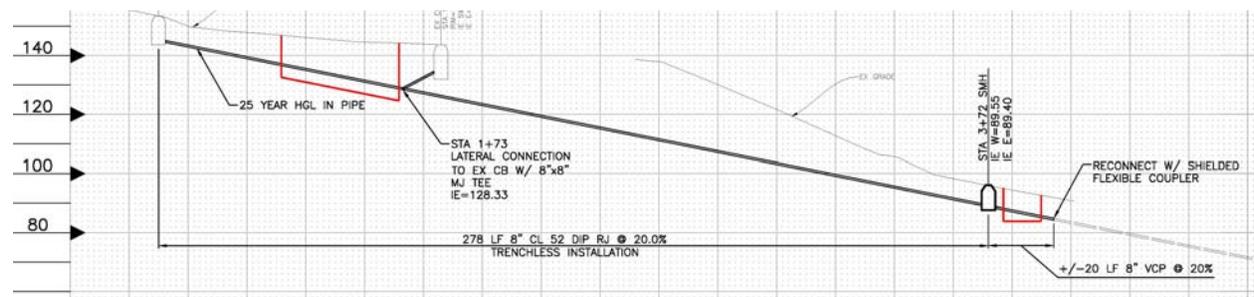
Figure 3. Conceptual Profile developed by SPU and edited by STC.

The trenchless replacement Option Two, included feasibility analysis of both pipe ram engulfment and pipe bursting. Pipe ram engulfment involves ramming an oversized casing around the existing pipe from a launch pit to a receiving pit. Once the oversized pipe is rammed over the existing pipe, the engulfed soil and existing pipe is removed from within the oversized casing and a new pipe can be constructed in the clean casing. Alternatively, pipe bursting is a technique where a bursting head is pulled through an existing pipe, fracturing or splitting the pipe as it proceeds, while concurrently pulling in a new pipe. Unique to this project, a rope had been threaded through the existing pipe before it collapsed and could possibly be used to facilitate initiation of the pipe bursting methodology. Figures 3 and 4 illustrate the conceptual profile and plan, respectively, developed by SPU with pit locations, revised by STC, shown in red.

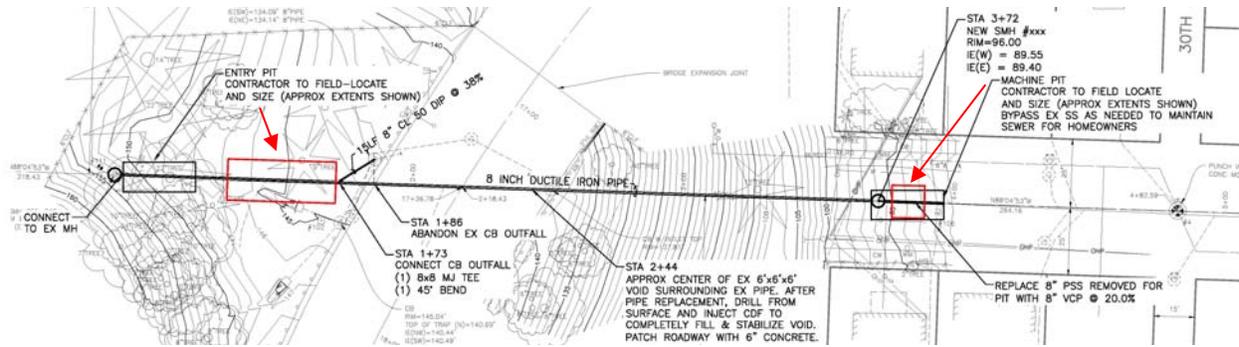
Figure 4. Conceptual Plan developed by SPU and edited by STC.

To provide room for pit excavation and shoring, as well as support for trenchless activities, SW Orleans St on the west side of the alignment would have to be temporarily closed to residential parking, inconveniencing the adjacent homeowners. The temporary closure could have been intermittent or may have needed to last for the duration of trenchless construction, depending on the technology. If the existing line were to have been replaced via pipe bursting, the pit would have been actively used for the duration of the burst, installation of the new MH, and connection to the downstream system. Access to this pit would not have been required for the duration of pipe ram engulfment; however, as the majority of the trenchless construction work would have proceeded from the up-station pit.

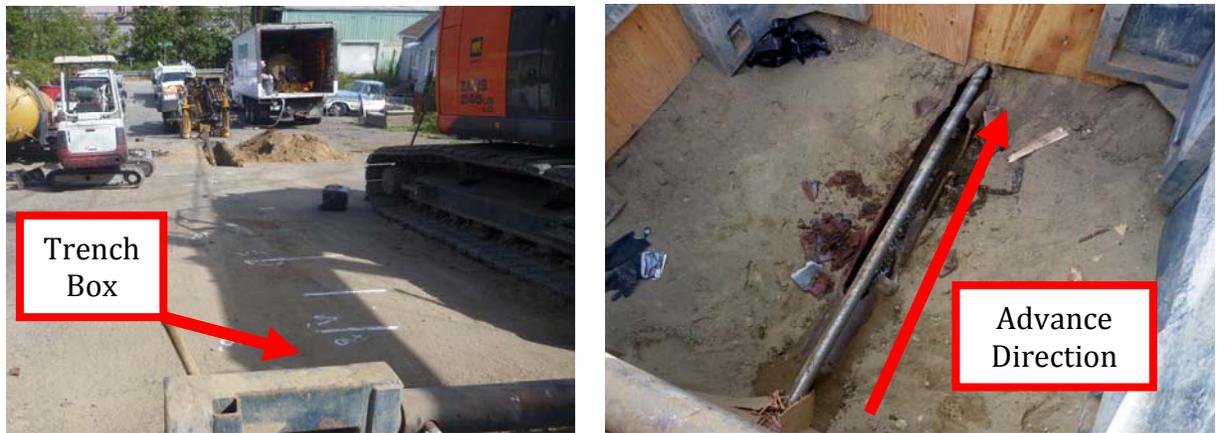
Figure 5. Vermeer D36x50 Setup (Left); Drill Pipe Entering Existing 8-inch VCP in Trench Box (Right)

Trenchless construction began on August 24th, 2015 (site preparation had been completed by the subcontractor the prior week, and included excavation of both the jacking and receiving pits). Trenchless Construction used a Vermeer D36x50 drill rig with a Vermeer LP 855 SDT Vac-Tron drilling fluid tank/pump. By 2pm Trenchless Construction was ready to begin inserting drill rods into the existing pipe at the necessary line and grade (21% slope, 8.5 degree entry angle). The drill rig was set back from the exposed 8-inch VCP approximately 40 feet, or the length of 4 drill pipe in order to achieve the entry angle. The existing rope through the pipeline was determined to be more of a potential detriment than useful, and it was cut and removed. When the drill bit on the lead drill pipe entered the trench box with the exposed 8-inch VCP, the pitch was a positive 6 degrees. Figure 5 illustrates the drill pipe entering the existing pipe. By 4pm 9 drill pipe had been advanced, extending roughly 50 feet through the existing 8-inch VCP. Since the extent of the collapsed pipe and subsequent surcharging upstream was unknown, it was desirable to refrain from puncturing the blockage so late in the day, and work for the day was wrapped up by 4:30pm.
