North American Society for Trenchless Technology (NASTT)
NASTT's 2015 No-Dig Show

TA-T4-03

Pipe Ramming Through Challenging Subsurface Conditions in the Pacific Northwest

Matthew P. Olson, Staheli Trenchless Consultants, Lynnwood, WA
Christopher G. Price, Staheli Trenchless Consultants, Lynnwood, WA

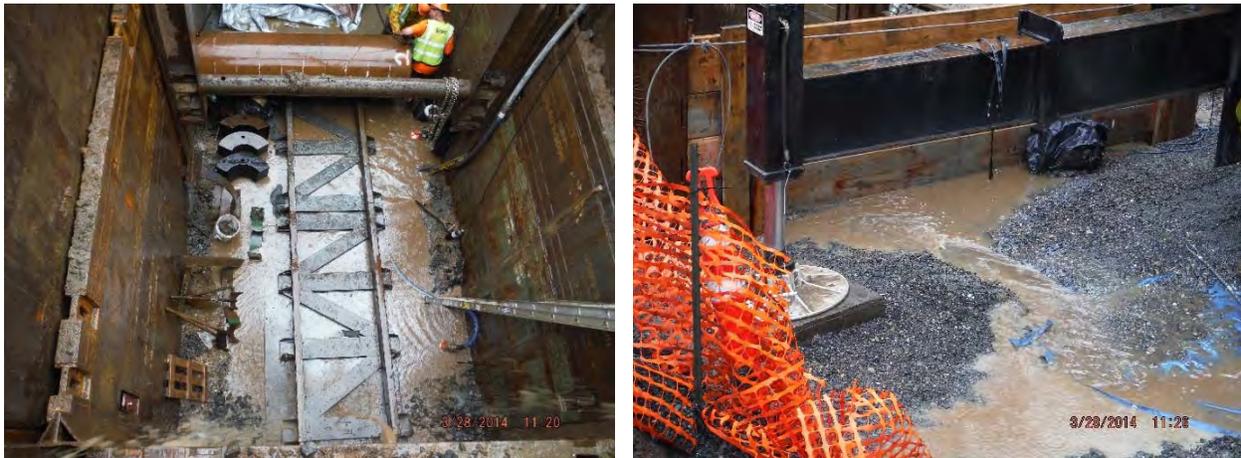
The project was awarded to K/E Excavating with Gonzales Boring and Tunneling as the trenchless subcontractor. Pipe ramming began on Thursday, March 28th 2014. Staheli Trenchless Consultants (STC) was scoped to perform construction inspection for a total of two days on the project and was not present on the first day of trenchless activities that included launch of the first 10-foot casing. An STC inspector was on-site on the second day of trenchless activity, which began with setting up the second 10-foot casing in the launch shaft. Upon discussion with Gonzales' foreman, STC learned that the first casing was installed using an auger boring machine (ABM) without spoil removal with the augers. Thus, the spoils were still inside the first casing. Little progress was made the first day due to the significant rainfall throughout the day and the abundance of surface water making its way into the launch shaft (Figure 1).

Figure 1. (Left) Flooding within the Launch Shaft; (Right) Channel of Surface Water Flowing into the Launch Shaft

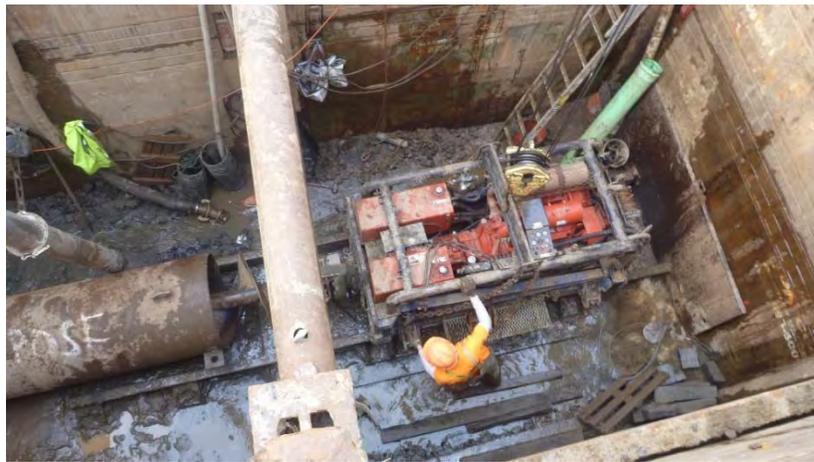
The crew returned on Thursday and began inserting auger flights into the casing. When they were asked for their construction plan they said they would insert augers all the way up to the face and attempt to auger out the spoils as they jacked the casing forwards with the ABM. They were hoping that whatever was stopping them at the face would be excavated by the cutterhead, allowing for forward progress of the casing. The Design Team was not alone with their worries regarding the groundwater head at the face; before auger boring began Gonzales used chain rigging on the ABM so that they would be prepared to lift the ABM out of the shaft should it flood upon cleaning out the casing (Figure 2).

Figure 2. Crane Ready to Pick ABM in the Event of Significant Water Flow through Casing

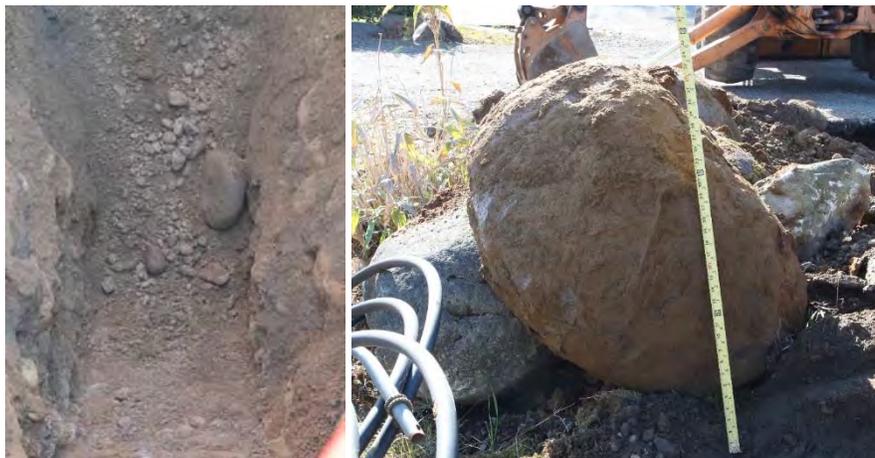
STC was hired at the 60 percent design level to evaluate feasible trenchless construction methods and develop trenchless related contract documents. To gain a stronger understanding of the frequency and size of the boulders and to gain first-hand knowledge of the soils and their behavior, STC met the Camas Public Works crew on site to observe the excavation of two test pits dug on each end of the sanitary sewer alignment. The southern test pit, located approximately 65 feet south of the railroad, indicated a distinct transition between the overlying medium stiff silt layer and the underlying sandy clay matrix with gravel, cobbles, and boulders. The largest boulders encountered were located near the transition between the two soil types. The first large boulder was unearthed 6 feet below ground surface, translating to an elevation of approximately 43 feet which coincides with the contact transition shown in boring B1. At a depth of 7 feet the soil transitioned from a brown sandy silt to a gray sand with numerous cobbles. Three boulders ranging in size from 2 to 3 feet were discovered by the time the test pit was 8 feet deep. Boulders/cobbles near 1 foot in size were slightly more abundant. Figure 3 (left) and Figure 3 (right) depict the bottom of the southern test pit at a depth of roughly 8 feet and the largest boulder (3 feet) encountered during the excavation, respectively.

Cobbles and boulders were not encountered in the test pit at the northern terminus of the alignment. Absence of boulders within this test pit is likely attributable to the ground surface being 7 to 8 feet higher in elevation than at the southern end and the maximum achievable excavation depth for the backhoe being 10 feet deep. Based on excavation of the test pits and correlation to the boring logs, it was anticipated that cobbles and boulders would be encountered at elevations less than 42 and 35 feet at the southern and northern ends of the sanitary alignment, respectively. Groundwater was not encountered in either of the two test pits, and the sides of the excavations were stable at a near vertical side slope for the duration of the exploration.

Figure 3. (Left) Southern Test Pit at 8 Feet Deep; (Right) Three Foot Boulder from Southern Test Pit

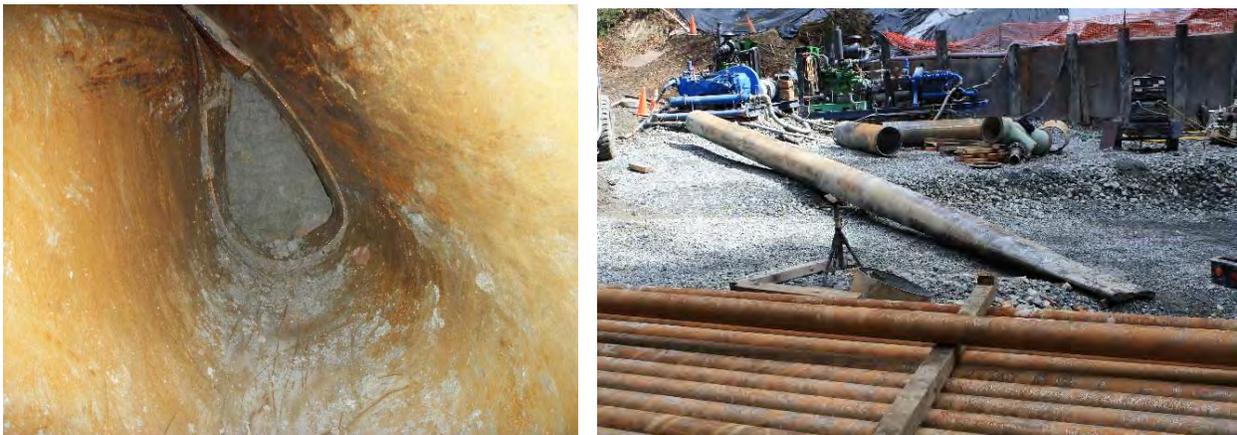
Once the alignment and trenchless construction method had been selected the specification was written to minimize project risk for both the Contractor and Owner. Figure 4 illustrates examples of what can happen to a casing in the event of repeated hammering against an impenetrable object. It is not uncommon for the lead edge of an underdesigned casing to crumple upon repeated hammering against an obstruction. Since it was understood that the likelihood of encountering boulders along the alignment was high, significant design effort needed to be allocated to specifying the necessary casing minimum wall thickness, casing steel specified minimum yield strength (SMYS), cutting shoe minimum thickness, and cutting shoe steel minimum SMYS. The goal of specifying minimum strengths and thicknesses was to give the Contractor enough confidence to ram against a boulder until the boulder broke and the casing could be rammed through or the boulder deflected to the inside or outside of the casing. By increasing the up-front cost of the steel, the amount of times required to access the face and remove a boulder would decrease and accordingly, construction duration and associated costs would decrease.

Figure 4. (Left) Crumpled Casing due to Point Loading; (Right) Flattened Casing due to a More Uniform Load

The geotechnical report indicated that basalt boulders would be present, but did not describe the strength of the basalt. Basalt strength can vary significantly, but has been generalized to have unconfined compressive strengths ranging from a minimum of 15,200 pounds per square inch (psi) to a maximum of 52,011 psi, with an average strength of 31,053 psi (Johnson and DeGraff, 1988). It was desired to increase the strength of the steel casing beyond the standard ASTM A36 grade B steel (SMYS of 36,000 psi) to an A572/50 steel with a SMYS of 50,000 psi to increase the steel yield stress beyond that expected of the basalt. To ensure a sufficient casing thickness, a nominal casing diameter to thickness (D/T) ratio was specified to be a maximum of 64, resulting in a casing thickness of 0.75 inches or greater for a 48-inch diameter casing. Since the lead edge of the casing, or cutting shoe, would be the point of contact with a boulder, it was particularly important to ensure the strength and stiffness of the cutting shoe would be sufficient to withstand the stresses imposed by the hammer and point loading from boulders. A cutting shoe steel SMYS of 60 ksi and a D/T maximum of 27 was specified to ensure a yield strength above the maximum anticipated boulder compressive strength and rigidity sufficient to prevent collapse of the casing's lead edge. As assembled, the cutting shoe would have a thickness greater than 1.7 inches.

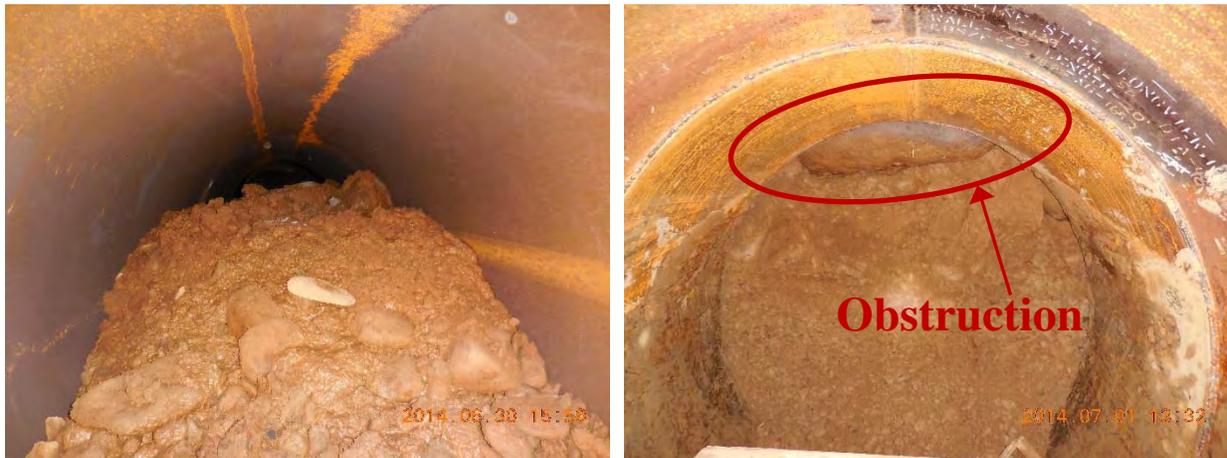
The bid was awarded to 3 Kings Environmental, Inc. on April 15, 2014. Stadel Boring and Tunneling, Inc. (Stadeli) was subcontracted to perform the pipe ramming work. The pits for the water main installation were complete and pipe ramming commenced on Monday, June 30, 2014 towards the end of the day. Within 45 minutes of starting the ram, and with 10 feet of installed casing, the casing hit an obstruction (Figure 5, right). The obstruction was hit along the casing crown, which caused the ground surface to heave 3 inches and the casing to deflect downward. At this point, the depth of cover to the casing crown was approximately 5 to 6 feet. Stadeli cleaned out the spoils within the casing (Figure 5, left) and proceeded to blast the boulder with an Ezebreak Micro-Blaster. The crew then proceeded to clean

out above and below the casing, requiring the blasting of an additional boulder to provide room to jack the casing back on alignment. First attempts to realign the casing were unsuccessful, requiring the Contractor to rent an additional 100 ton jack. It took two days for the boulders to be removed and for the casing to be realigned to the design grade.

Figure 5. (Left) Soughing of Interspatial Soils; (Right) Obstruction at the 12 o'clock Position

During the two days the crew was removing boulders and adjusting the casing they requested to switch from pipe ramming to a combination of auger boring and hand mining to finish the drive. They were concerned that pipe ramming would cause unacceptable ground surface movements, which would be a significant problem in the vicinity of the railroad tracks. Their request for a method switch was granted. The obstruction measurement and payment specification language was stressed to the Contractor to reiterate that they would not be paid for removing engulfed spoils or retracting their augers to access the face.
