**North American Society for Trenchless Technology (NASTT)
NASTT's 2018 No-Dig Show**

**Successful Risk Management Through Specialized Construction
Inspection for Pipe Jacking**

Joel Staheli, Staheli Trenchless Consultants, Lynnwood, WA
Kimberlie Staheli, P.E., Staheli Trenchless Consultants, Lynnwood, WA
Mark Hutchinson, P.E., Staheli Trenchless Consultants, Lynnwood, WA

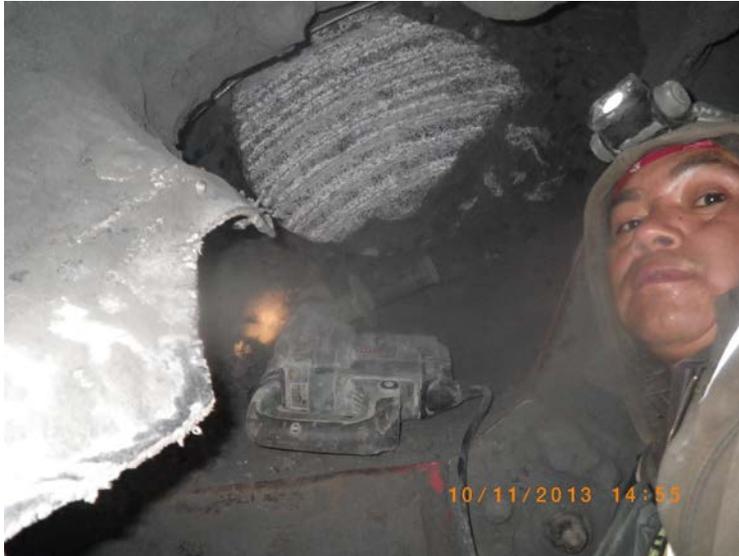
Figure 2 shows one of the larger boulders that was encountered during Drive 3, taking approximately 10 hours to remove using a hand-operated rock drill and rock splitter. The picture is taken from inside the shield, by the inspector, looking out at the excavation face. The curved lines on the face of the rock are thin grooves created by the cutting teeth during the revolution of the cutterhead. Due to the density of the soil holding the boulder in place, it was able to remain suspended even after removal of the supporting soil beneath it. The operator and inspector were alerted to the presence of this and other rocks by both surges in the torque pressure on the cutter head and the sound of the scraping of the cutting teeth against the rock as the cutting arm would pass over it.

Figure 2. Boulder embedded in the excavation face. Picture is taken from inside the shield by specialized inspector.

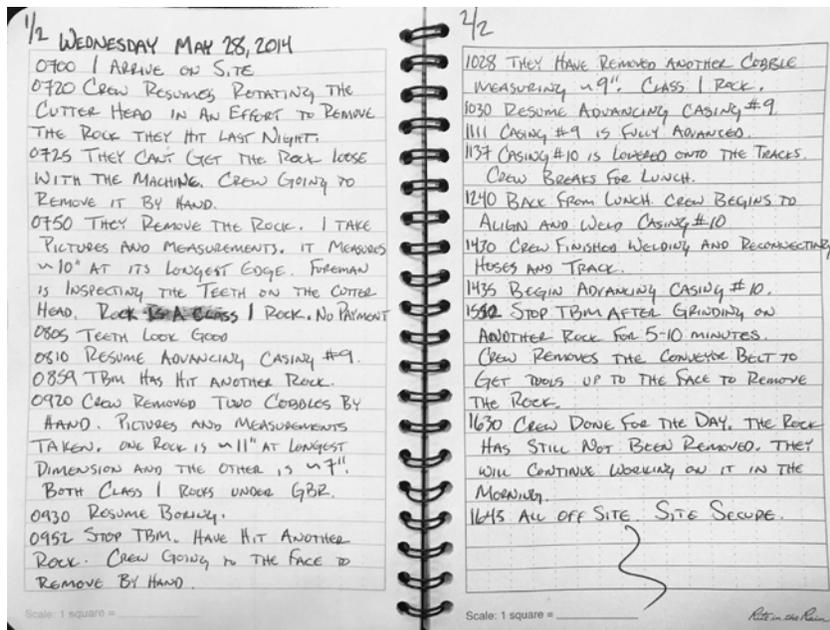
The Contractor launched the TBM and was able to advance five 20-foot casing sections without encountering any boulders. On the sixth casing section a rock was encountered; however, upon removal it was discovered to be less than 14 inches in the longest dimension and thus in classification group #1 and not eligible for extra payment. Over the next 80 feet of installation, the Contractor encountered eight additional rocks that required stopping the machine for removal. Of the rocks encountered, all were either determined to be cobbles (less than 12 inches) or boulders in the 12 to 14-inch range and thus in classification group #1. The removal of these rocks generally took between 10 minutes and two hours depending on the orientation and placement of the rock with respect to the excavation face. The inspector verified the sizes of each of these rocks as well as the time it took the Contractor to remove each and recorded it in his field book. Figure 5 is another excerpt from the inspector's field notes depicting the details of the non-pay rocks.

Figure 5. Excerpt from the inspector's field notes.

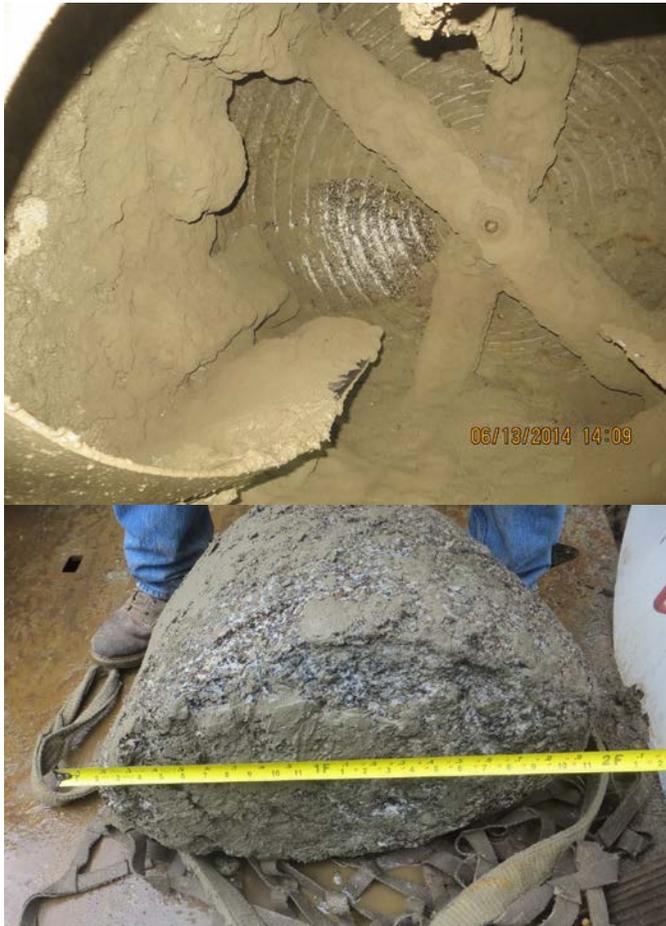
Approximately 200 feet into the drive, the Contractor encountered the first boulder larger than 25-inches. Approximately 25.1-inches in the longest dimension, this boulder took approximately 11 hours to remove from the excavation face. Around 100 feet further, they encountered a second boulder larger than 25 inches, this one being approximately 25.3 inches in the longest dimension. The second boulder took approximately 4 hours to remove. Based on size, these two boulders were both in classification group #3. Figure 6a shows a picture of the excavation face with the first boulder visible at the 9 o'clock position. Figure 6b shows the boulder after removal.

Figure 6. View of the boulder from inside the shield (top) and upon removal (bottom). Pictures taken by inspector, note the tape measure for scale.

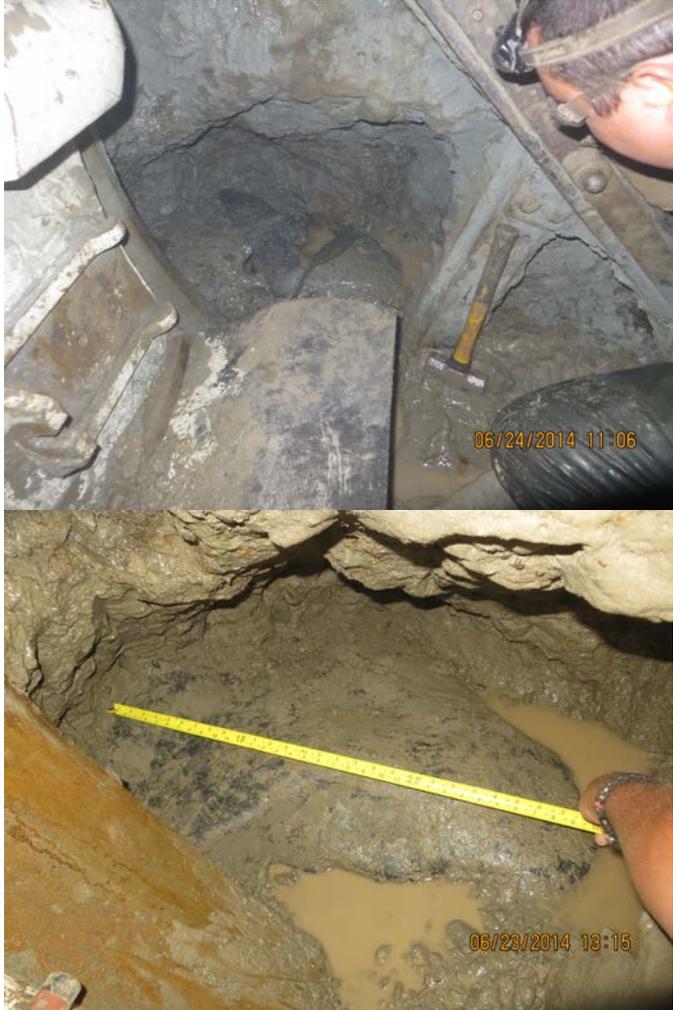
In total, it took 34 days to complete the 530-foot crossing, resulting in an average production rate of 15.5 feet a day. Of those 34 days, approximately 3.5 were spent in removing the fourth boulder in classification group #3, which was encountered less than 20 feet from the reception shaft. The inspector's detailed records showed that this boulder took substantially longer than the others due to both the placement of the boulder on the edge of the machine periphery, and due to mechanical problems with the Contractor's dewatering system (Figures 7a, 7b). The detailed records allowed the CM team and Owner to determine how much time was taken to remove the obstruction and how much time was taken to deal with the mechanical problems, which weren't the Owner's responsibility. Despite these difficulties, the pipe jacking work was successfully completed.

Figure 7. View of boulder from inside the shield (top) and with a tape measure for scale (bottom). Pictures taken by the inspector.
