3RD TIME'S THE CHARM: SOUTH TAHOE HDD SUCCESS SOFTENS BAD MEMORIES OF PREVIOUS FAILURES

Jack Burnam P.E., Project Manager – Carollo Engineers
Kimberlie Staheli P.E., Principal – Bennett/Staheli Engineers
Richard Solbrig Assistant Manager/Engineer – South Tahoe Public Utility District
Jim Hoggatt Construction Manager – South Tahoe Public Utility District

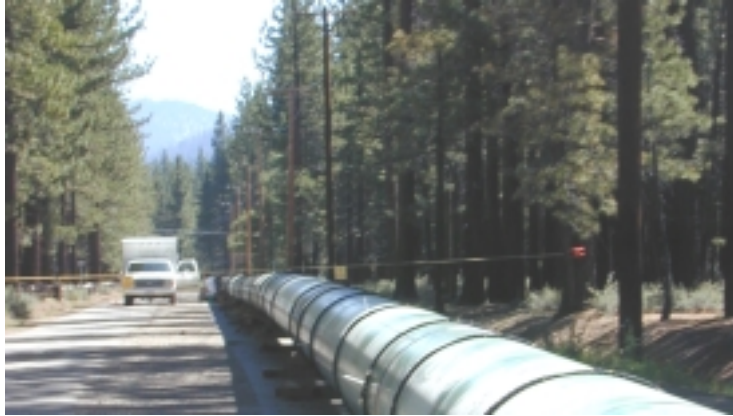
Figure 1 Welded and Coated Pipe String on Barbara Avenue

required thickness of the steel pipe walls not the internal working pressures. A 3/8-inch wall thickness was needed to accommodate an internal 250 psi working pressure. However, anticipated pulling forces required a wall thickness of 1/2 inch. Lining and coating was also an important consideration. The type of lining and coating had to be flexible and well bonded to the steel pipe to withstand the bending and flexing of the pipe as it was pulled into place. In this case, fusion-bonded

epoxy was used to line and coat the steel pipe. The pipe was delivered to the site lined and coated with fusion-bonded epoxy to within 6 inches of each end. After the ends of each pipe section were squared and welded together, the inside and outside were sandblasted to remove weld slag and the exposed pipe brought back to “near white” condition prior to field applying the fusion bonded epoxy at the joints.

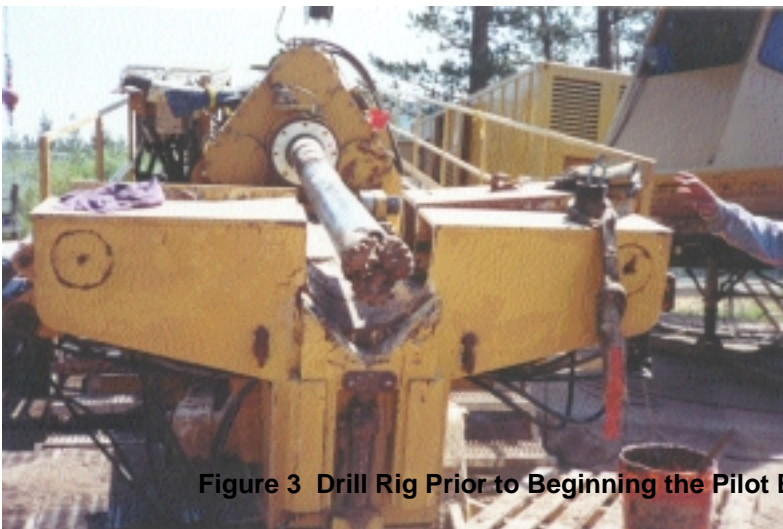
Figure 3 Drill Rig Prior to Beginning the Pilot Bore

Cherrington corporation was the HDD sub-contractor for the construction of the pipeline. They used a drilling rig manufactured by Cherrington with a 200,000 pound pull back capacity. A TruTracker downhole tracking system was used to determine the location of the drill head during drilling. The TruTracker coil was laid on the surface on both sides of Trout Creek and the position of the coil was surveyed and entered into the computerized tracking system. The construction of the pipeline began on July 29, 2000 and was completed on August 17, 2000.

The pilot bore began on July 29, 2000. An 8-1/2 inch tri-cone bit with 2 jet nozzles was used as the cutting tool. On the first day of drilling, the contractor installed 6 drill pipes or approximately 180 feet of the 1,200 foot pilot bore. During drilling of the 6th drill pipe, the drill head encountered the hard, dense sand layer and had difficulty penetrating the formation. On July 30th, Cherrington installed drill pipe 7 through 17; however, the hard ground resulted in steering problems and the contractor had to re-drill each pipe for position. Some drill

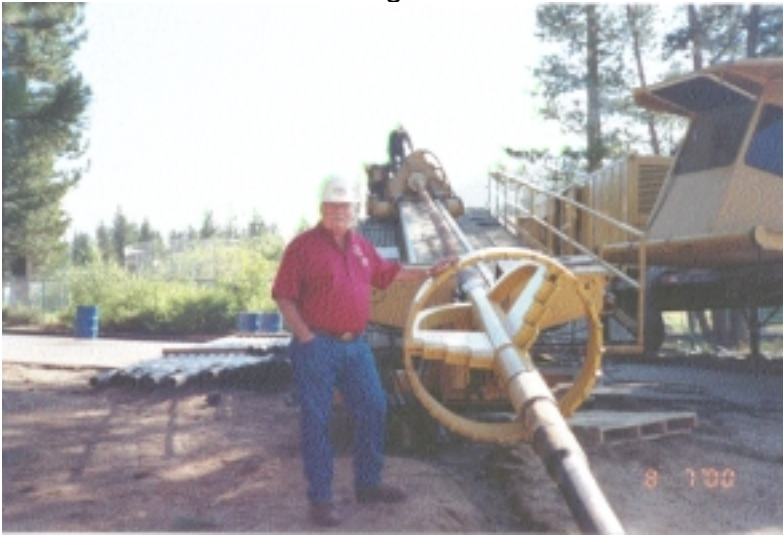
Figure 4 Fly cutter prior to the forward reaming

Cherrington chose to enlarge the pilot bore to the full 42-inch diameter in a single reaming pass. They chose to forward ream from the rig to the exit location with a fluid assisted fly-cutter reamer. The reaming was completed in 7 working days. The mud handling capabilities of the mud plant limited the progress of the reaming operations. Due to the large volume of silt and

During the forward reaming pass, the down-hole mud pressures were higher than during the drilling of the pilot bore, as indicated by the increase in pressure noted at the peizometers locations. The water table rose 6 inches when the reamer was over 100 feet away from the peizometers along the bore path. As a result the contractor slowed the drilling operations and lowered the overall drilling mud pressure as they were crossing Trout Creek to guard against the possibility of drilling mud escaping into the creek.

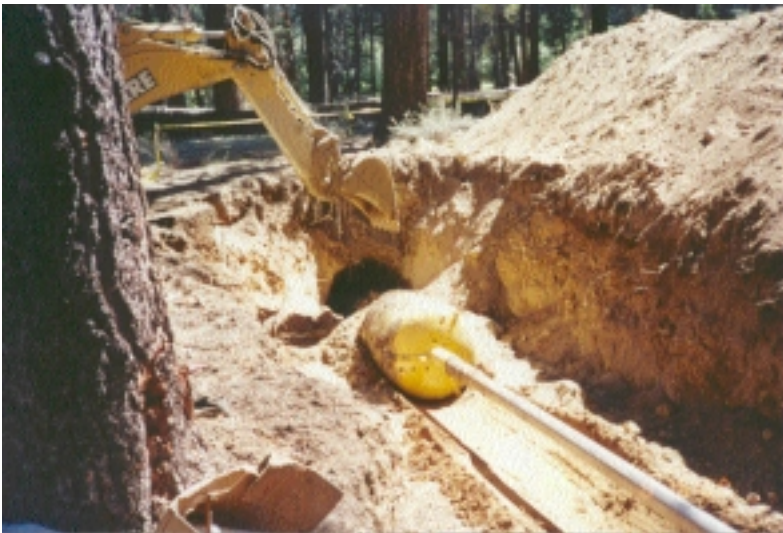
Figure 5 Beginning the barrel ream

After the forward reaming pass, a barrel reamer was used to back-ream and swab the borehole.

The barrel reamer's main function was to compact the soil on the periphery of the borehole to stabilize the hole prior to pull-back of the product pipe. Barrel reaming took place in a single day and was completed on August 16, 2000.

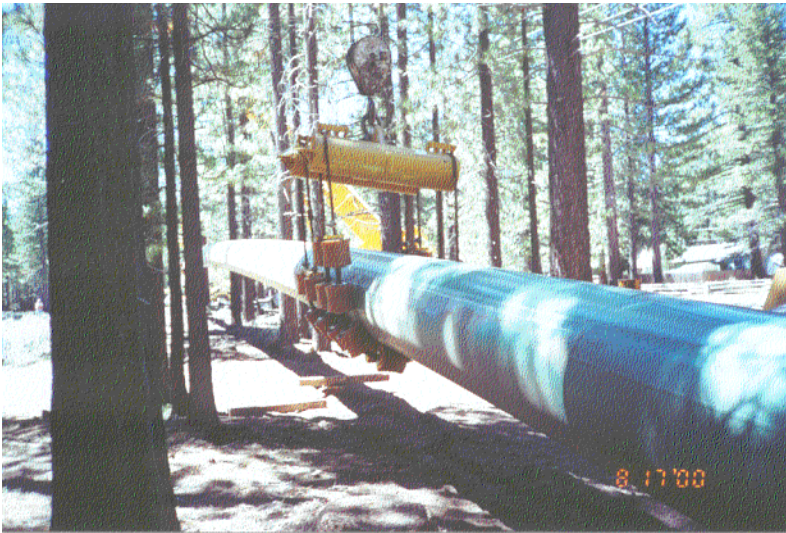
Figure 6 Pipe pull-back

Pull-back operations began on August 17th. Large capacity cranes were mobilized to the site to lift the 30-inch pipe to facilitate pulling the pipe into the hole without over-

stressing the pipe string. Pull-back operations were started at 1:40 pm and the full 1,200-foot pull was completed at 6:10 pm. Pull-back forces peaked at 168,000 pounds. Interestingly, on the last pull, the contractor had difficulty removing the reaming assembly from the pipe string. This was largely due to the high torque that was applied to the string during the pullback operations. It took the contractor 45 minutes to remove the reamer. After removing the reamer, they attempted to pull the pipe string the final 40 feet. However, due to the delay, the pipe froze in the ground. Although they applied the full 200,000 pounds of available force, the contractor was not able to move the pipe again. As a result the tie-in location was adjusted at the completion of the project.
