**North American Society for Trenchless Technology (NASTT)
NASTT's 2018 No-Dig Show**

**Pipe Ramming:
Understanding the Forces that Drive the Industry Forward**

Kimberlie Staheli, Ph.D., P.E., Principal Engineer, President, Staheli Trenchless Consultants, Seattle, WA.
Armin Stuedlein, Ph.D., P.E., Associate Professor of Geotechnical Engineering, Oregon State University, Corvallis, OR
Paul Richart, P.E., Capital Projects Manager, Alderwood Water and Wastewater District, Lynnwood, WA

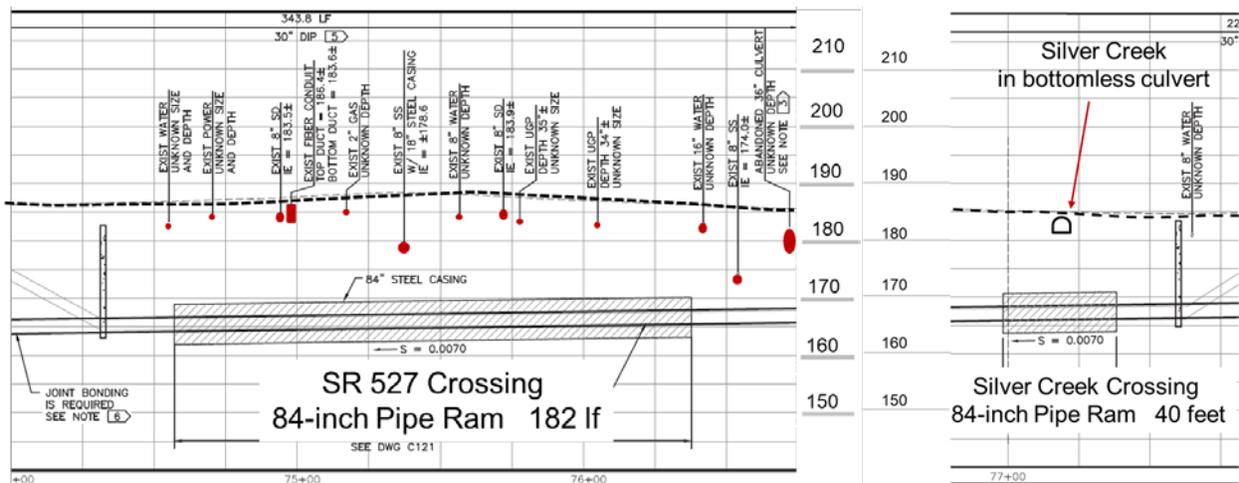
Within the segment under evaluation, there were two crossings in close proximity that required trenchless installations– one beneath Highway 527, a very busy roadway that contained many utilities, and the other beneath Silver Creek which could not be open cut as it was a salmon-bearing stream. Figure 1 shows the profiles of the crossings on the project.

Figure 1 Crossing of SR 527 and Silver Creek Crossing

The crossing of Highway 527 was designed to be approximately 182 feet long and the Silver Creek Crossing was designed to be approximately 40 feet long; however, during construction, the Contractor elected to lengthen the ramming shaft from what was shown on the plans and shift it towards SR 527 resulting in a shortened crossing length of SR 527 totaling 120 feet and a longer Silver Creek crossing of 60 feet.

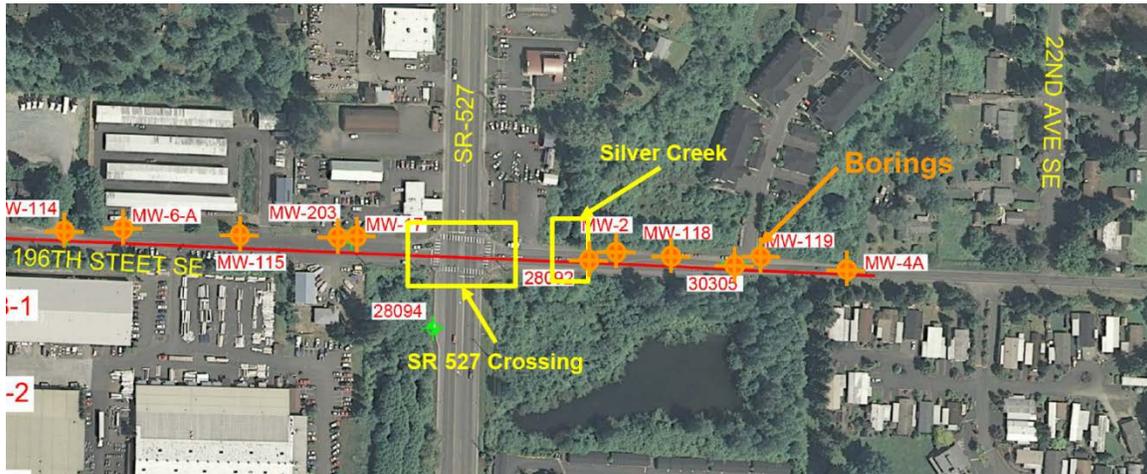
Figure 2 Locations of SR 527 and Silver Creek Crossings and Geotechnical Borings along the Alignment

Figure 2 shows the geotechnical borings from the original project in relation to the trenchless crossings. It was determined that the existing geotechnical borings were sufficient for characterizing the soils along the crossings. There were three major categories of soil units used to describe the geotechnical conditions at the site: 1) recent fill deposits; 2) alluvium and recessional outwash deposits (post-glacial deposits); and 3) dense glacially overridden deposits. The trenchless crossings were all within the post-glacial deposits and dense glacially overridden deposits. These units were described as follows:

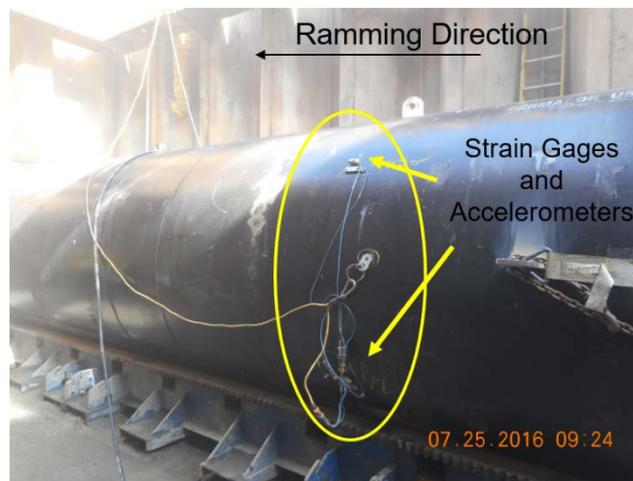
Some of the specialty requirements included the design of a temporary pipe plug that would counterbalance the groundwater pressure to prevent soils from flowing into the face of the ram. The Contractor was also required to design a cutting shoe that met a diameter to thickness ratio that was developed by the pile driving industry and had been adapted to pipe ramming (Price and Staheli, 2013). The most unique requirement and one that would prove to be most valuable during construction, was providing real-time instrumentation of the pipe ram. The specifications required the contractor to hire an instrumentation specialist that met requisite qualifications to perform instrumentation monitoring during the pipe ram. The specification outlined how each pipe was to be fitted with strain gages and accelerometers in accordance with ASTM D4945 (ASTM 2017) which governs High Strain Dynamic Testing of Deep Foundations. The Contract required that each pipe be fitted with four pairs of strain gages and accelerometers at locations that were 90-degrees apart on the outside of the pipe, approximately one pipe diameter from the hammer-casing interface. Signals from the sensors were collected during ramming and were to be processed with Pile Driving Analyzer ® (PDA) manufactured by Pile Dynamics, Inc. Figure 3 shows the instrumentation mounted on the pipe during construction.

Figure 3 84-inch outer-diameter pipe showing position of strain gages and accelerometers that were monitored during ramming operations.

The instruments were attached to each pipe section and connected to the data logger that was located on the ground surface to allow real-time data monitoring without the need for personnel within the shaft during the ramming operations.

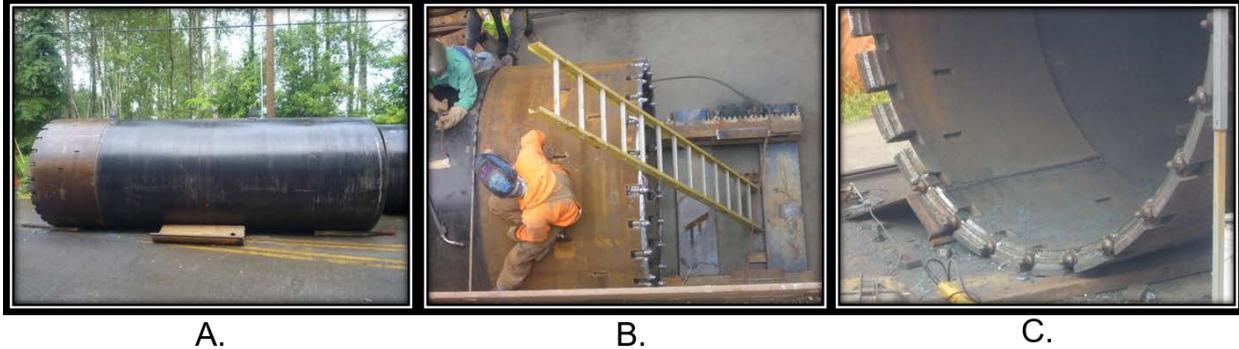
The contractor chose to use a heavily reinforced cutting shoe that contained Kennametal bullet bits to provide point loading to break high-strength cobbles and boulders. The bullet bits were nested within the 3.5-inch thick shoe in pockets of hardened steel to protect them from breaking in the harsh ground conditions. The specification required

the cutting shoe design to meet a nominal casing diameter to cutting shoe thickness ratio (d/t) of 30 (minimum). The pipe had an outer diameter of 84-inches and a 1.25-inch diameter wall. The cutting shoe was four feet long and was attached to the lead casing that was 20 feet in length. Figure 4 shows the cutting shoe that was used on the SR 527 Crossing.

4 Cutting Shoe. A. Attached to lead pipe section. B. Top View – welding lubrication line in the shaft. C. Close-up of lower section of shoe during fabrication and insertion of bullet bits.

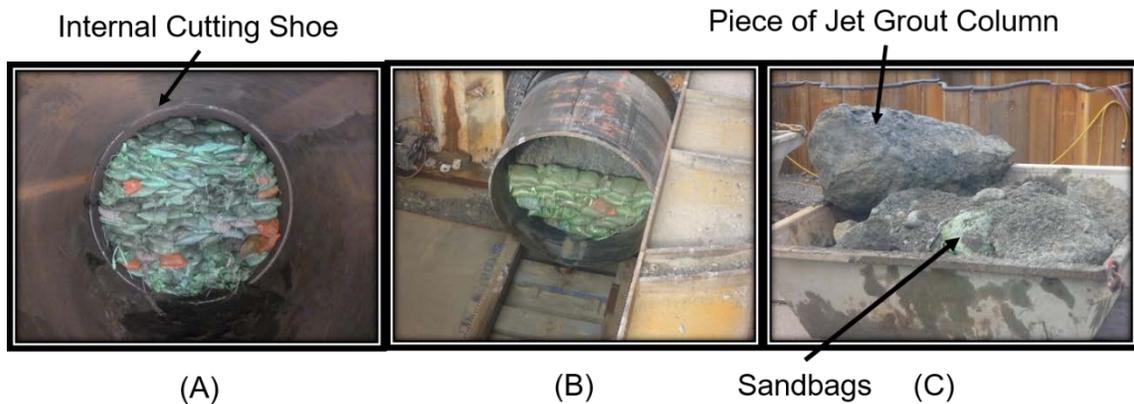
The contractor chose to use a sand bag pipe plug approximately 10 feet in length. In addition, jet grouted columns were installed outside of the sheet-pile shaft to allow launch of the ram beneath the groundwater without loss of soil into the shaft. Once the first pipe was rammed, the sand bags were displaced as the pipe filled with soil. The hammer was removed and the sand bags were removed from the pipeline. The natural soil replacing the sand bags served as the pipe plug and counterbalanced the groundwater head and the tendency for soil to flow within the pipe. During ramming operations, groundwater continuously flowed into the shaft, providing a relief of pressure. However, the soil plug provided a counter-balance to soil flow and the loss of stabilization at the face. Figure 5 show the sand bag pipe plug prior to launch of the ram and the sand bags when the hammer was removed from the back of the first casing.

Figure 5 Sandbag pipe plug. (A) First layer of Sandbags at face. (B) Sandbags pushed to back of pipe after pipe rammed and hammer removed. (C) Muck cart with portions of the jet grout columns and sand bags found when cleaning out the casing.

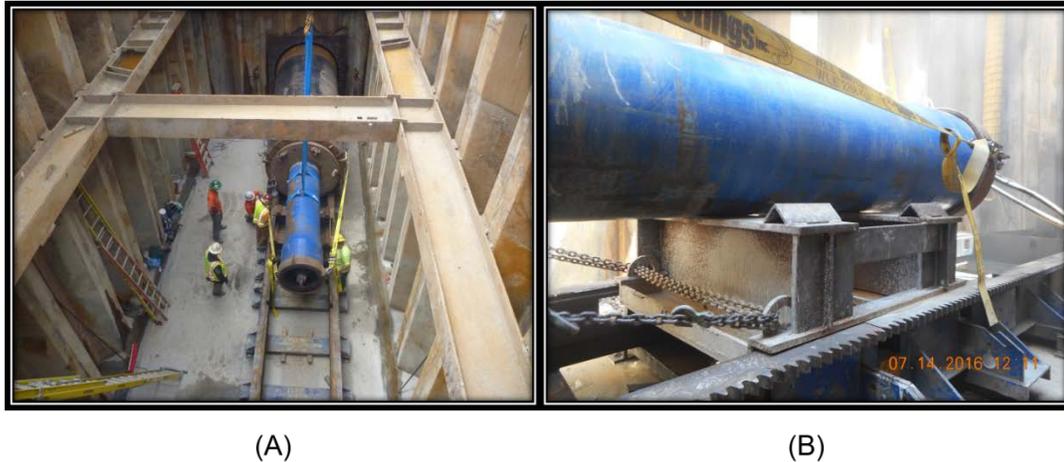
The pipe ramming hammer used on the project was a Grundoram Taurus pneumatic hammer manufactured by TT Technologies. The hammer was reported to have a maximum rated energy of 29 kip-ft and a maximum operational speed of 180 blows per minute. During pipe ramming, the hammer was supported by a sled that was attached to the

pipe rails that were surveyed into position. This feature was required by specification to ensure that the hammer would be fixed at the design grade during ramming. The designers felt it was important to use a mechanism to align the hammer to minimize any angle introduced at the hammer-casing interface, which has been shown to reduce energy transfer (Meskele and Stuedlein, 2013; 2015a). It was hoped that this feature would increase the grade accuracy of the method. Figure 6 shows the hammer and the cradle/sled that would support the hammer on the pipe rails.

Figure 6 (A) Grundoram Taurus pneumatic hammer. (B) Hammer Sled to hold hammer to design grade.

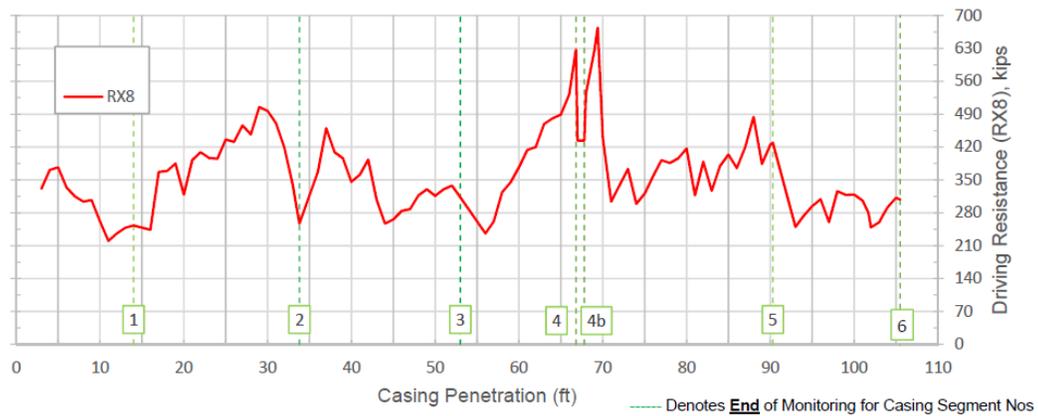
The Driving Analyzer ® was used to estimate the ultimate driving resistance based on the Case Method “RX8” quantity computed by the PDA (Goble et al. 1975; Rausche et al. 1985; Meskele and Stuedlein 2015a, 2015b). Figure 7 shows the ultimate driving resistance for the ram beneath SR 527.

Figure 7 SR 527 – Casing Penetration v. Driving Resistance and Hammer Operation (RMDT, 2016)

At the beginning of the ram, during installation of the first pipe segment, the operator used a considerable amount of caution when ramming through the jet grout columns and did not operate the hammer at the maximum blow rate of 180 bpm (blows per minute). Upon initiation of the ram, significant rebound of the cutting shoe was observed at the interface of the jet grout columns because of the lack of reaction force that could be provided by pipe embedment through frictional resistance (Meskele and Stuedlein, 2015b). This caused some difficulty getting the hammer to fully seat into the hammer-pipe adapter. The force inferred by the PDA measurements at approximately 5 feet of penetration was primarily due to resistance at the face. Once the pipe advanced to an embedment of 11 feet, the jet grout columns and engineered pipe plug was fully engulfed within the pipe and the force reduced from 375 to 225 kips, where it would then increase linearly, indicative of an increase in frictional resistance along the circumference of the casing, consistent with the findings of previous research. (Stuedlein and Meskele 2013; Meskele and Stuedlein 2015b). Ramming of the first casing segment was completed at a penetration distance of 14 feet, leaving 5 feet of casing within the shaft.

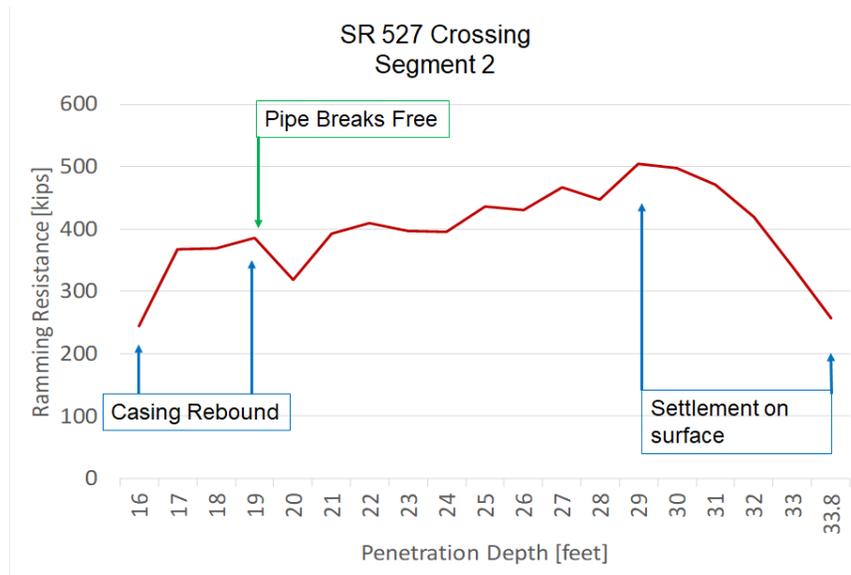
ram lost stability during this segment, largely because the pipe was filling with soil while not ramming on the boulder without casing advance. As a result, the face pressure force was markedly reduced from previous readings, resulting in a reduced penetration resistance measured by the instrumentation. The resulting surface settlement was most significant at approximately 20 feet from the shaft and a sink-hole approximately 40 inches deep manifested above the crown of the pipeline. The settlement trough followed the pipeline for a length of approximately 8 feet. Luckily, the settlement above the pipe had arrested prior to entering beneath SR 527. Figure 8 presents the variation of the penetration resistance versus penetration depth while ramming Segment 2, identifying the events that took place while ramming. Clearly, the observations made during ramming are correlated to the penetration resistance inferred from the dynamic analyses, similar to those demonstrated by Meskele and Stuedlein (2015a).

Figure 8 Casing Penetration Depth v. Ramming Resistance and events while ramming Segment 2 on the Highway 527 Crossing

The data collected on Segment 4 revealed the most interesting trend on the project. While ramming Segment 4, the ramming forces went up substantially, increasing to a maximum of 670 kips. This can be seen on Figure 8 at a penetration depth between 56 and 65 feet. In addition, ramming rates rose from 3.5 to 14 minutes per foot over the duration of the ramming, and 1600 blows per foot was required by the hammer to move Segment 4. The Contractor's data manager came to the shaft and explained to the operator that the data indicated a significant resistance at the front of the pipe. He also noted that the efficiency of the hammer had dropped over 50% in 4 feet of ramming. These findings were very concerning and the soil was removed once again from the pipe. Once the casing was cleaned, observations looking down the pipe from within the shaft clearly revealed that the front of the pipe was losing line to the left at a rapid rate. The curve in the pipe was noticeable with a naked eye. Upon measurement, it was discovered that the pipe was just over 24-inches off the design alignment, south of the line, although the grade of the pipe was within tolerance.

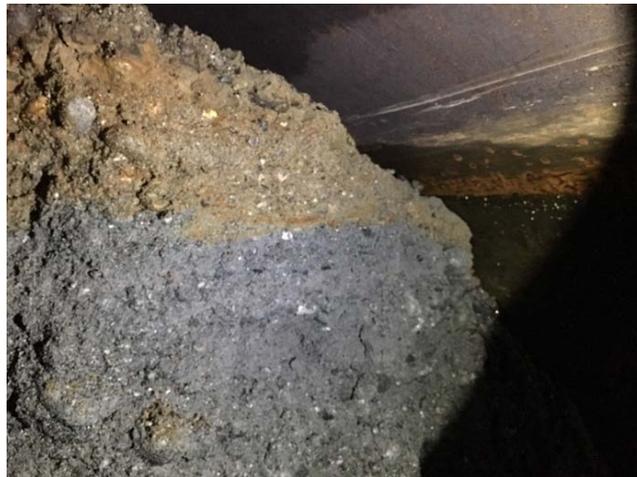
At the end of Segment 3, soils were removed from the pipe to lower penetration resistance. It was important to leave a plug in the pipe to counterbalance groundwater pressure; therefore, the Contractor elected to remove approximately 50 feet of spoils – leaving a 14-foot soil plug. Once the soil was removed, observations of the soil within the casing, as well as line and grade measurements were taken. Interestingly, in the middle section of Segment 3, the observed soil revealed a distinctly layered soil system. This was consistent with the geotechnical conditions identified in the geotechnical report, showing the dense glacial soils on the bottom of the pipe and the alluvial/recessional soils on the top of the pipe. It is believed that the face forces on the ram decreased when the ram broke into the alluvial/recessional deposits which exhibited a lower density than the dense glacial soils. Figure 9 shows the soil interface as observed within the pipe.

Figure 9 Soil inside leading pipe segment showing alluvium/recessional soils (brown) underlain by dense glacially overridden soils (gray).

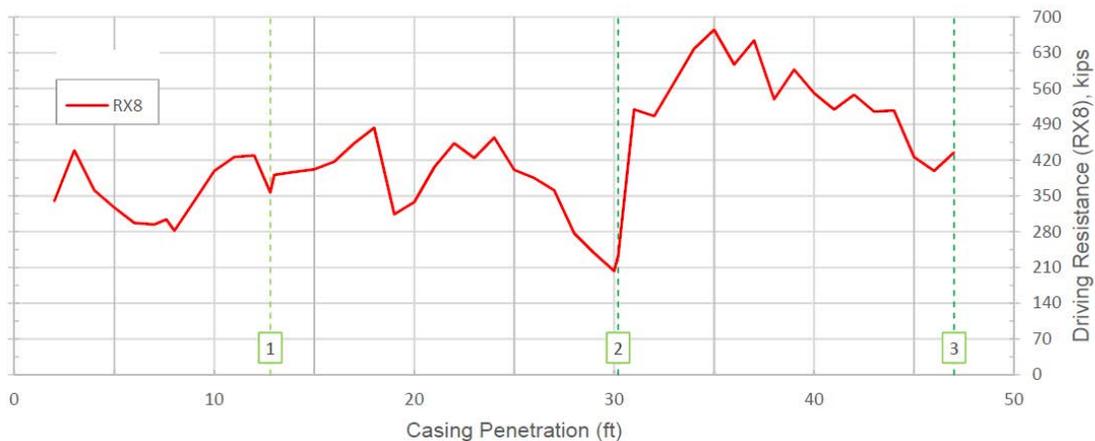
Upon completion of the SR527 ram, the equipment was turned 180-degrees within the shaft and the ram beneath Silver Creek was initiated. This ram was very short and only required three 20-foot segments of casing. Sand bags were used as a pipe plug to counteract the groundwater pressure, similar to the SR 527 Crossing. There was much more concern about the groundwater on this drive since this fish-bearing stream could not be dewatered into the casing. Figure 10 shows the variation of driving resistance with penetration depth of the casing.

There are similarities between the driving resistance curves for the SR527 and the Silver Creek crossings that deserve attention. For example, for Segment 1 on the Silver Creek Crossing when casing penetration was low, significant rebound was noted due to the lack of casing resistance with which to react against; correspondingly, a significant amount of rebound was observed. Simultaneously, an initially high amount of face resistance would be noted, followed by a reduction and corresponding slow rate of increase as the friction along the inner and outer surface of the pipe accumulated with increasing penetration length.

Figure 10 Casing Penetration v. Driving Resistance for the Silver Creek Crossing (RMDT, August, 2016)

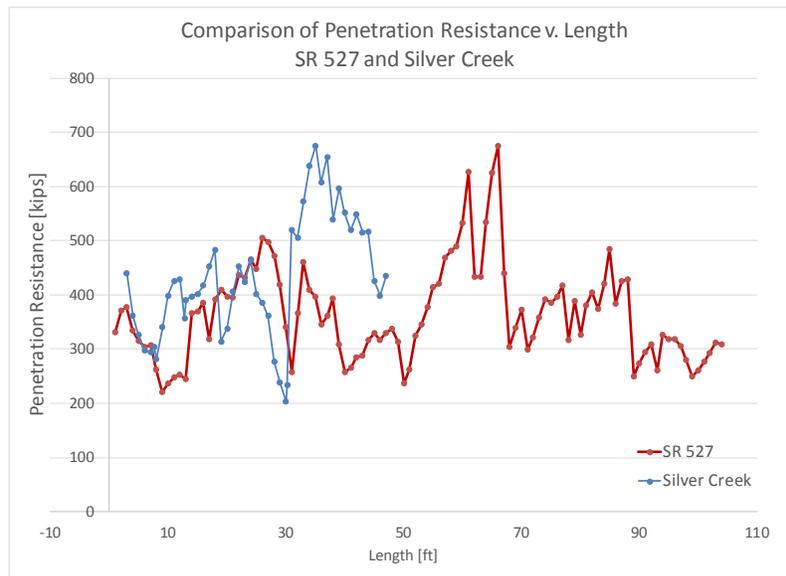
The most significant correlation between the two drives occurred during installation of Segment 3 at the Silver Creek installation, when a significant line deviation occurred as observed upon removal of soil. During the grade deviation, the penetration resistance increased from 210 kips to 660 kips – very similar to the increase that was realized on the SR527 crossing. The increase in resistance occurs due to the increased normal stresses (and therefore interface friction) acting on the pipe circumference over a length of approximately 10 feet over which the casing had bent. The increase in driving resistance was then followed by an overall decrease as the pipe continued forward and the initial high load that was required to bend the pipe was reduced. Figure 11 shows an overlay of the penetration resistance of the two rams.

Figure 11 Comparison of Casing Penetration v. Driving Resistance for the Crossings of both SR527 and Silver Creek Crossings.

The most significant factor may be the amount of increase in resistance that was measured when the pipe experienced deviations in design line (and likely in grade as well). With both casings, the overall ramming resistance increased by approximately 3 times the force prior to the pipe bending. This also requires more study but was significant considering the correlation between the two rams.
