North American Society for Trenchless Technology (NASTT)
NASTT's 2013 No-Dig Show

WM-T4-03

**Examining Pipe Ramming Design –
A Forensic Analysis of a High Risk Project**

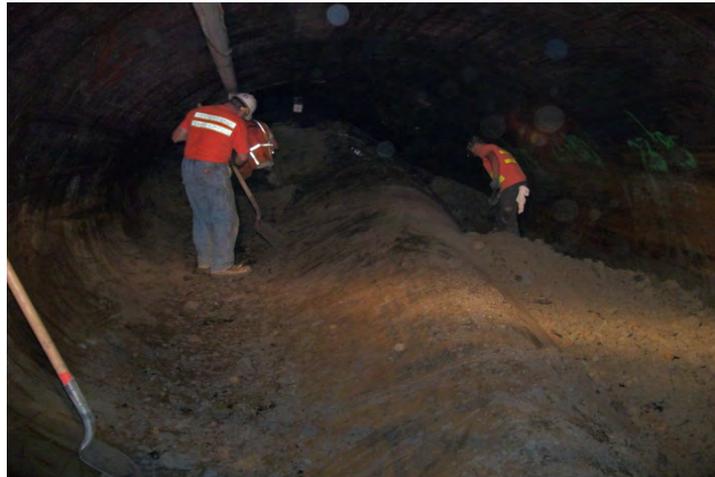
The 144-inch casing installation advanced 135 feet before progress slowed in the last foot of installation and eventually resulted in refusal of forward movement. After removing the hammer and excavating the material inside the casing, deformation was observed for the leading 70 feet of the casing. The deformation of the pipe began at the bottom center of the pipe and continued to increase vertically until the bottom of the pipe met the crown as seen in Figure 1. Based on the 70-foot length of damaged pipe, the pipe started to deform when it was approximately 65 feet past the insertion ring. To investigate the cause of the initial deformation, a hole was cut in the bottom of the casing pipe at the initial point of deformation. Meanwhile, pipe installation work stopped at the first crossing and the Contractor shifted operations to the 120-inch crossing.

Figure 1. Invert Deformation of 144-inch Casing

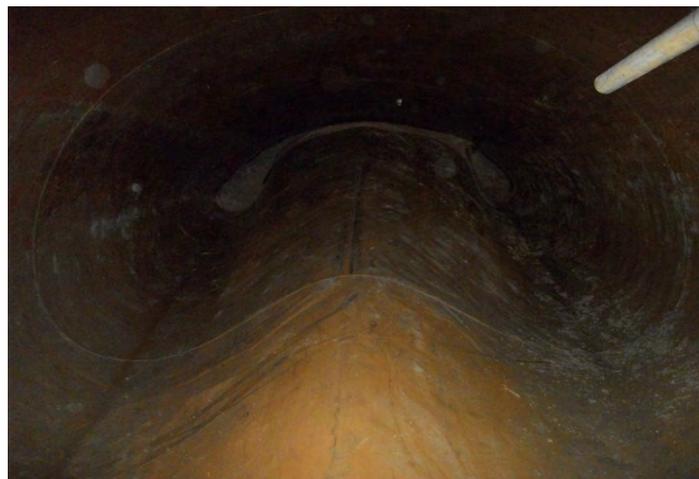
When ramming the second crossing, although there was no indication of damage, ramming was stopped approximately 105 feet into the ram to excavate within the casing and verify that the pipe was not being damaged. Unfortunately, the excavation operation exposed a damaged pipe. Approximately 35 feet of pipe was deformed at the invert. The deformation of the pipe began at the bottom center of the pipe and continued to increase vertically until the bottom of the pipe met the crown of the pipe as seen in Figure 2. Based on the 35-foot length of damaged pipe, the pipe started to deform when the pipe was approximately 70 feet past the insertion ring. There was no wood or rock present in the soil removed in the damaged section of pipe that would be considered an obstruction. Though the pipe failure manifested in the same fashion as on the previous crossing, there was no obvious evidence for the cause of failure. A hole was cut in the bottom of the casing at the location where the deformation initiated in an attempt to find a source of the failure and all pipe installation work stopped until a repair plan was developed.

Figure 2. Casing Failure with Invert Deforming to the Crown of 144-inch Casing

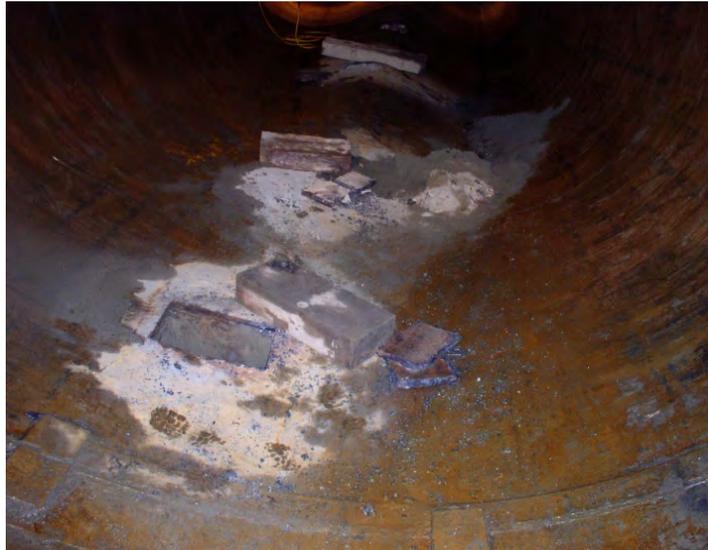
Investigation at the initial points of failure consisted of cutting out sections of the deformed invert to expose the surrounding soil and to excavate the immediately surrounding material as seen in Figure 3.

Three observations were made for both pipes at these locations.

1. There was no void space surrounding the pipe. The soil was in direct contact with the exterior pipe wall at all locations. There were no drag marks or voids created by displaced objects being pushed in advance of or being dragged along by the pipe.
2. The exterior material was dense glacial till consistent with that described in the boring logs, geotechnical investigation report, and in profiles provided with the contract documents.
3. No evidence of wood fragments, splinters, rock shards, or rock fragments, indicative of shearing through objects was found in the glacial soils. In addition, there was no evidence of displaced objects into the surrounding soil that would indicate the pipe rode over a large object causing deformation.

In both crossings, the leading cutting shoe failure had occurred and simply progressed to a point in which total collapse was achieved as the pipe was advanced. The mode of failure for both crossings was identical. The inverts of both pipes were deformed vertically upward beginning at the original point of failure and increasing linearly toward the leading edge of the pipe.

Figure 3. Exploratory Holes Cut into Casing Invert at Initial Point of Failure

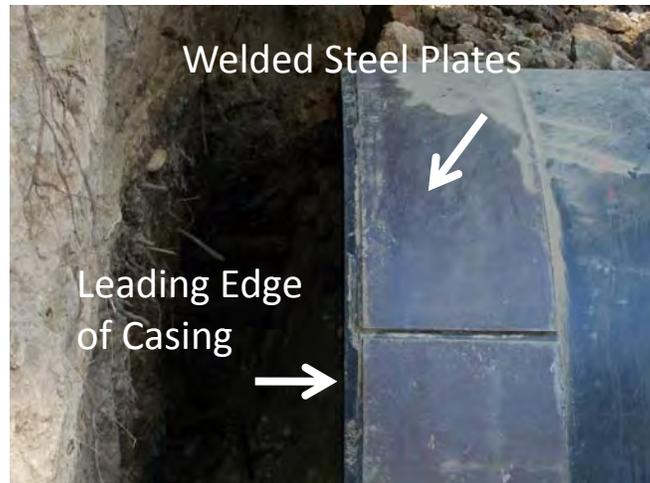
The cutting shoe bevel was cut in the incorrect direction, which lead to significantly high moment forces in the casing. The direction of the applied bevel is similar to that shown in Figure 8 and caused an internal moment in the casing as the pipe was rammed into the dense glacial soils called out in the contract documents. The resulting concentration of high stresses deformed the casing invert. As ramming progressed into the dense glacial soils, the deformed leading edge of the casing continued to fail until the invert of the pipe met the crown, resulting in total refusal of casing advance.

Figure 9. Failed Pipe Ram Cutting Shoe

Another problem of the cutting shoe design was that the reinforced band was applied behind the leading edge of the casing, forcing the casing steel to absorb the impact load of the soil instead of the cutting shoe. This is highly unusual as the concept of a cutting shoe is to apply a reinforced banding that will cut through the soil and relieve the stresses on the casing and avoid local failure of the casing material.

By not protecting the leading edge of the casing with a proper cutting shoe, it was prone to localized failure that manifested as “tearing” due to exceedingly high stresses. “Tearing” of the leading edge of the casing has been observed on other pipe ramming projects where insufficient cutting shoes have failed while ramming in dense soils where no obstructions were encountered.

The ultimate cause of the casing failure was an improper design of the lead casing pipe that was not stiff enough to prevent deformation. The primary inadequacy was the design of the cutting shoe which was beveled incorrectly, applied at the wrong location, and was not of sufficient thickness, which caused an abundance of stress at the bottom of the pipe that led to the deformation of the invert and ultimate failure. Other contributing factors to the failure were insufficient internal banding of the lead pipe and a casing wall thickness that was less than recommended for the casing diameters.
