**North American Society for Trenchless Technology (NASTT)
NASTT's 2013 No-Dig Show**

**Calleguas Municipal Water District Continues to Overcome Trenchless
Challenges on the Salinity Management Pipeline**

Shonna Sommer, P.E., Calleguas Municipal Water District, Thousand Oaks, CA
Matthew Pease, P.E., Staheli Trenchless Consultants, Bothell, WA

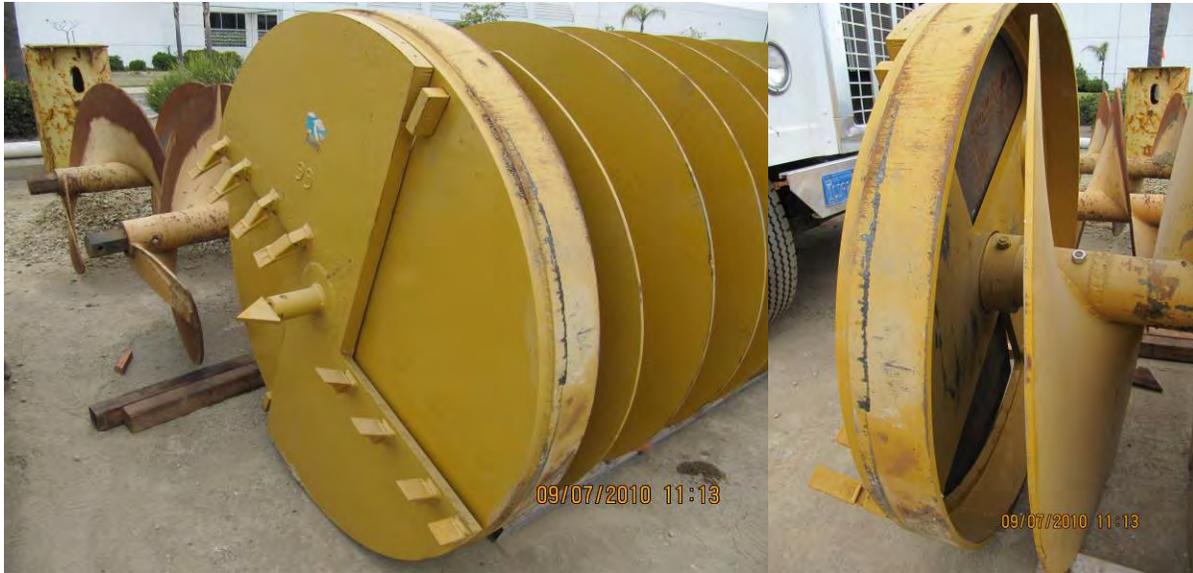
Figure 3. Sand Auger Flights

PB mobilized an Akkerman GBM 240A pilot tube machine and American Augers 48/54-900 G2 auger boring machine to the site to install the 20-foot lengths of casing. They also used a set of 30-inch and 66-inch sand augers produced by Michael Byrne Manufacturing (Figure 3). These augers have a heavy duty vertical face with “pie shape” doors that can be opened and close by rotating the auger to the left or right.

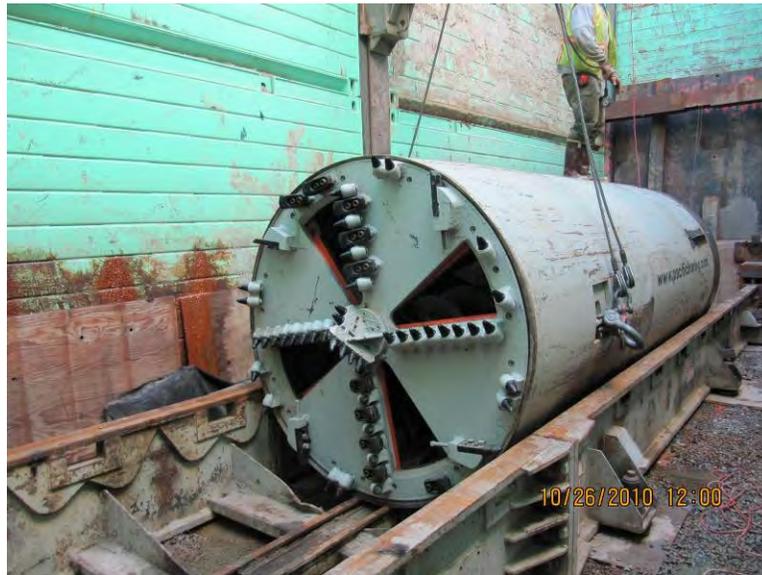
Figure 4. Akkerman TBM and cutter wheel

The method used to construct both of the shafts was slide rail shoring with deep wells for dewatering. No dewatering was done along the alignment due to the fact that the “J” Street Drain is typically full of water. When PB mobilized to the site, they elected to first advance their pilot tubes the length of the drive at the center of the tunnel horizon to “probe for obstructions” with their Akkerman GBM 204A machine. The pilot tubes were advanced the length of the drive without encountering any obstructions, so they removed the tubes before setting up the Akkerman TBM with 5000 Jacking System. The machine was equipped with a cutter wheel with closable hydraulic doors (Figure 4) and a screw conveyor for spoils removal to the electric locomotive mounted muck bin.

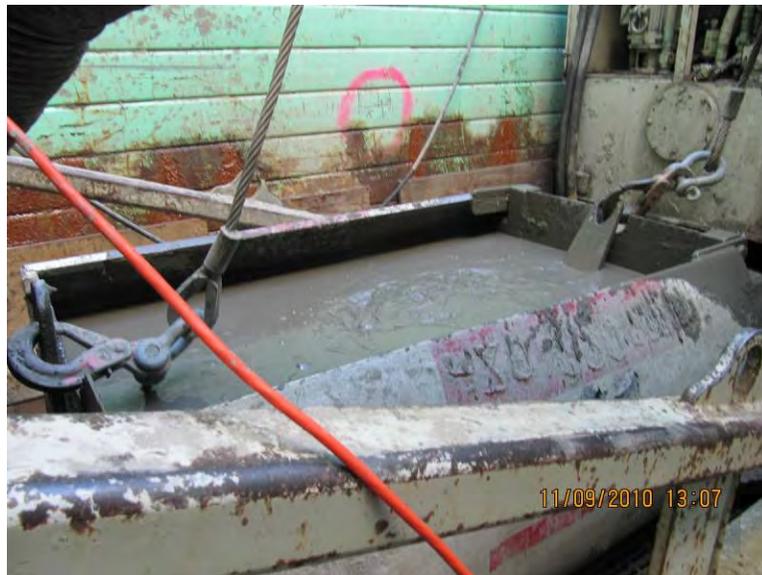
Figure 5. Saturated spoils in the muck bucket

Once the tunneling began, the only real issue on this drive was the amount of groundwater encountered. Once the tunnel was advanced past the zone of influence of the dewatering wells around the launch shaft, the amount of groundwater greatly increased. The rotation of the cutter wheel on the TBM caused the material to basically liquefy

as the machine advanced (Figure 5). However, the tunneling continued and the TBM reached the shaft after 13 days of tunneling with only one sinkhole occurring at the western/near side edge of the “J” Street Drain.

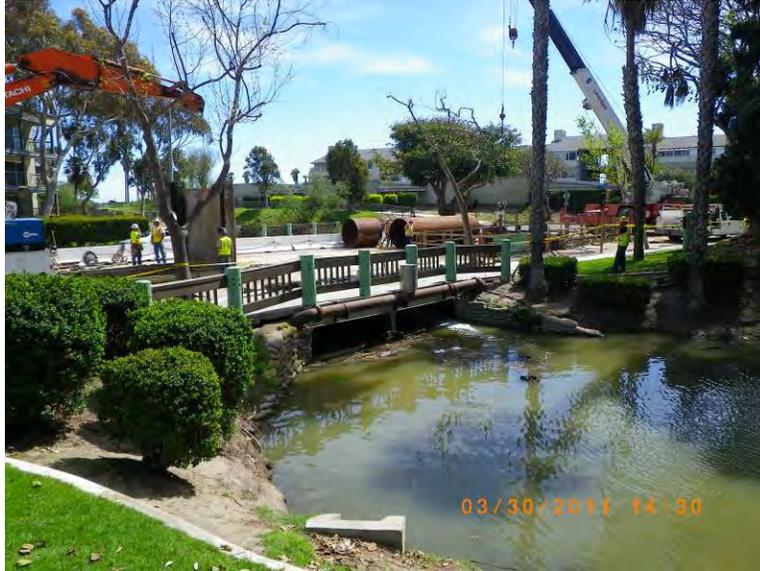
Figure 6. Bubbling Springs Crossing

The next crossing to be completed was under Bubbling Springs/Hueneme Drain (Figure 6), a box culvert. This crossing was not originally planned to be a trenchless crossing. The contract drawings depicted the crossing to be constructed by supporting the 28-foot wide by 5.5-foot high concrete channel by placing wide flange beams underneath and on top and connecting the beams with chains, thereby supporting the channel while the soil underneath was removed and the 48-inch pipe was installed. However, WGC had concerns about this design and requested that they be allowed to have PB install an additional auger bore crossing. The 45-foot long crossing was completed successfully in three days by conventional auger boring in a single pass.

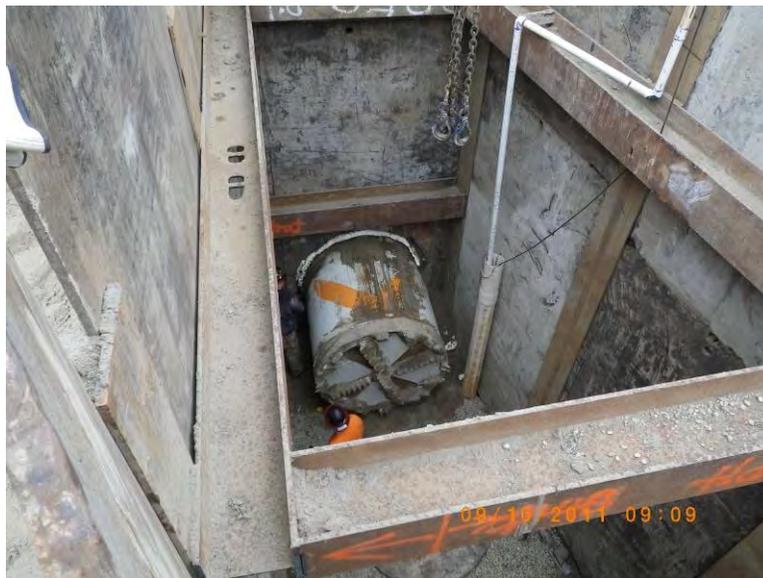
Figure 7. TBM entering the Reception Shaft

This casing consisted of 116 LF of 0.75-inch wall, 66-inch diameter welded steel casing at a depth of 20 feet. This tunnel was included as part of the work to cross underneath a busy intersection with a number of utilities which would make for difficult open cut construction. The launch shaft was constructed using slide rail with deep wells. The reception shaft was constructed of beams and steel sheets, also with deep wells to control groundwater. The material was damp sand which made for good tunneling on this drive. The work was completed over the course of four days of single ten hour shifts (Figure 7).

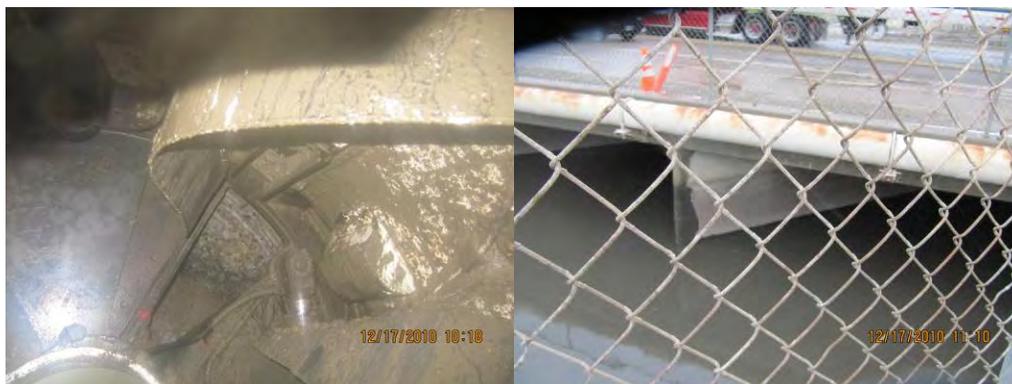
Figure 8. Concrete Obstruction beneath the OID and a view of the wall supporting the roadway above the drain

The obstruction that the TBM had come in contact with appeared to be part of the concrete for the drain. Whether or not it was actually part of the drain could never be definitively confirmed, but the concrete appeared to be part of a footing for the first of three stem walls that supported the roadway above the drain (Figure 8). The obstruction was difficult to investigate further given the safety risks posed by having an active drainage way directly overhead, the unstable soil conditions, and the amount of water that was flowing into the TBM. Tunneling operations were stopped until the situation could be assessed and a new approach developed.

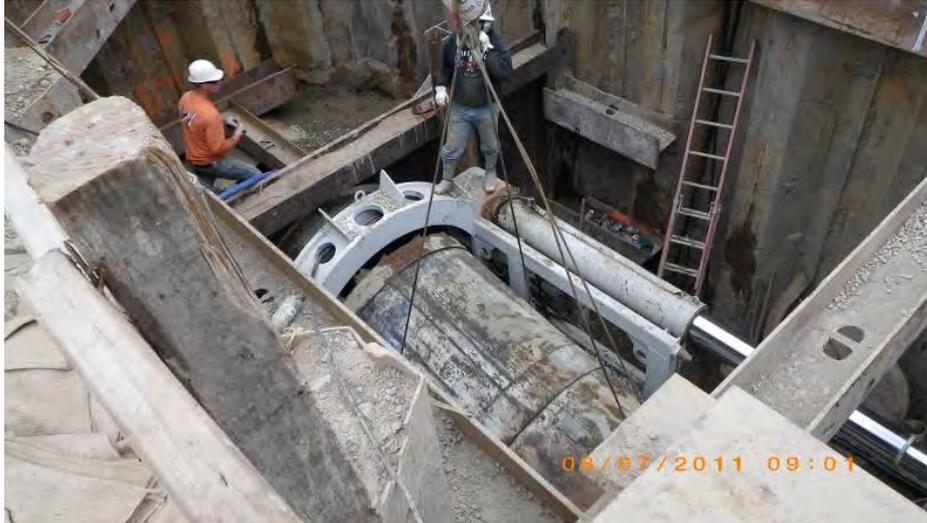
Figure 10. TBM Pulled into the Shaft with an 800-ton jacking frame operating in reverse

Once the rescue shaft was completed PB mobilized to the site, bringing with them an 800-ton jacking frame and a 20-foot long section of 84-inch casing. They then used the jacking frame to advance the 84-inch casing over the TBM, thereby fully engulfing the TBM. By doing this, PB was able to ensure that the concrete-lined channel above the tunnel would be fully supported before the TBM was pulled back in to the rescue shaft. After the 84-inch casing was advanced approximately 12 inches beyond the face of the TBM, PB repositioned their jacking frame so that the frame could be operated in reverse and used to pull the TBM in to the rescue shaft. The frame was disassembled and reinstalled in the shaft, after which 1-1/2-inch Dwidag bars were used to connect the back ring of the TBM to the front of the jacking frame. PB then pulled the TBM back in the shaft approximately 4 feet before pumping grout between the 84-inch casing and the 68-inch OD TBM in order to fill the void in front of the TBM and support the face of the excavation. This proved to be difficult since groundwater continued to flow in to the casing during the entire procedure.

On the following day PB was concerned about the grout curing to the point that would make the TBM difficult to pull out, so they elected to attempt to finish pulling the TBM all the way back in to the rescue shaft. PB was able to do this with relative ease, only needing about 200 tons of thrust to pull the TBM into the shaft (Figure 10).

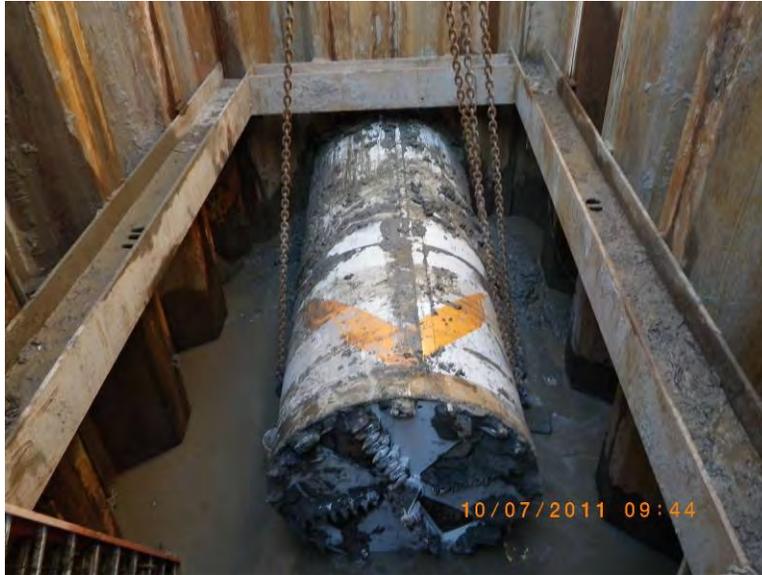
Figure 11. TBM being hoisted out of the Reception Shaft

The TBM was finally launched through the seal and almost immediately encountered a dense dark gray clay layer that was absent of free-flowing water. The tunneling proceeded without incident all the way to the reception shaft located just east of the OID. Unfortunately the outside of the shaft was not being effectively dewatered and PB had to spend some additional time cutting holes in the shaft wall and recovering the TBM than they would have had the reception shaft been adequately dewatered. The day after the tunneling was completed, the TBM was lifted out of the shaft and the PB crew grouted the annular space outside the casing (Figure 11). The product pipe was then installed and sand was blown in between the casing and the 48-inch product pipe.
