**North American Society for Trenchless Technology (NASTT)
NASTT's 2014 No-Dig Show**

MM-T5-02

**Salvaging the Lessons Learned from a
Difficult Microtunneling Project**

Kimberlie Staheli, Ph.D., P.E., Staheli Trenchless Consultants, Seattle, WA
Peter Robertson, Ph.D., P.E., Gregg Drilling and Testing, Huntington Beach, CA
Paul Vadnais, Vadnais Corporation, San Diego, CA
Dylan Davidson, Staheli Trenchless Consultants, Seattle, WA

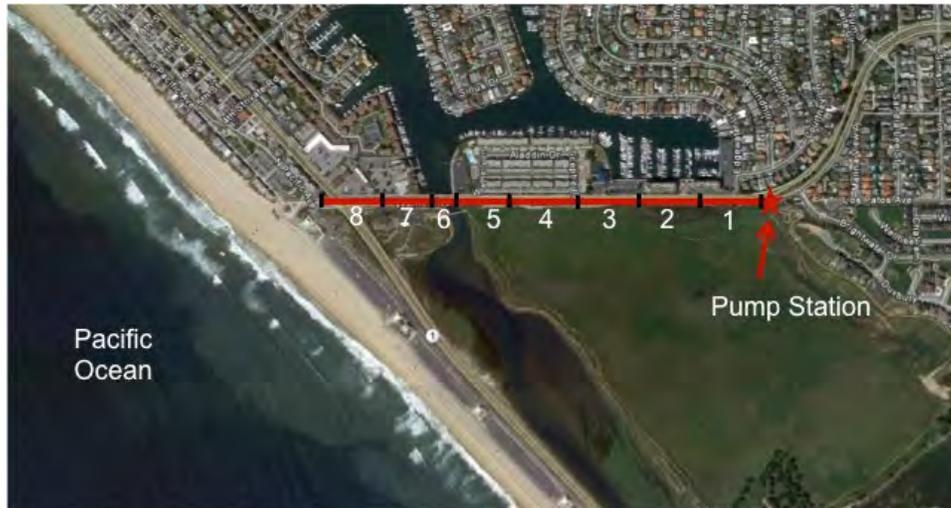
the wet well of the lift station as a reception shaft, and the following seven drives were to move away from the lift station toward the Pacific Ocean, as can be seen in Figure 1. Of critical importance was Drive 6, which was to traverse beneath a channel within a critical wetland area with less than three feet of cover above the crown of the pipe on a very flat grade of 0.1%.

Figure 1. Plan view of Project Site showing Drive Numbers and Location.
