**North American Society for Trenchless Technology (NASTT)
NASTT's 2018 No-Dig Show**

**Successful Risk Management Through Specialized Construction
Inspection for Pipe Jacking**

Joel Staheli, Staheli Trenchless Consultants, Lynnwood, WA
Kimberlie Staheli, P.E., Staheli Trenchless Consultants, Lynnwood, WA
Mark Hutchinson, P.E., Staheli Trenchless Consultants, Lynnwood, WA

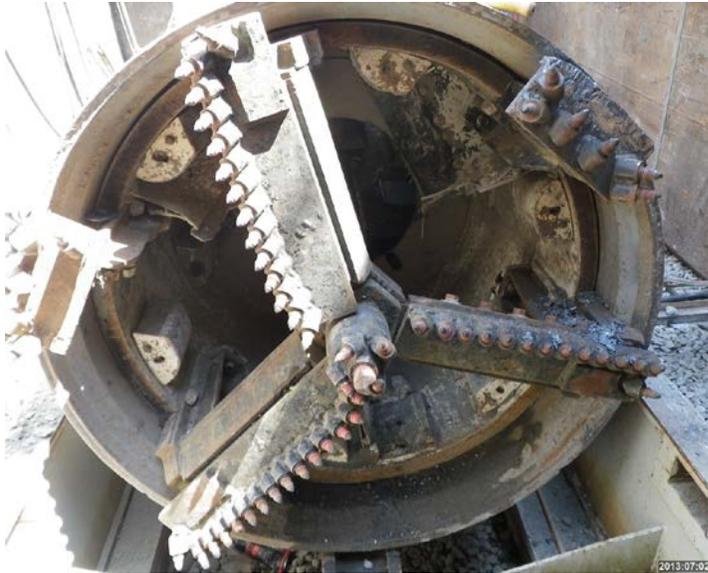
The Contractor elected to use a 60-inch outside diameter (OD) Akkerman 480B tunnel boring machine (TBM) for the three drives. The cutterhead is accessible from the front of the TBM to easily remove obstructions; however, removal of the conveyor is typically required to access the face of the excavation with hand tools including rock drills, rock splitters, and roto-hammers. Figure 1 shows the TBM in the jacking shaft prior to launch.

Figure 1. TBM in the jacking shaft.

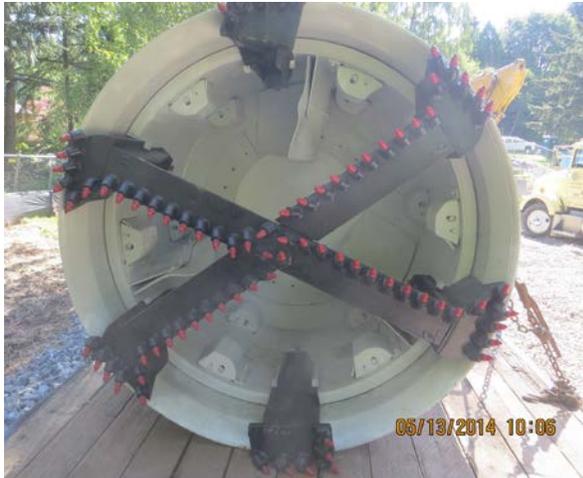
Figure 4. Front view of the TBM prior to launch.

When the same boring Contractor that worked on Project #1 was awarded this project it was fairly easy for the inspector and the Contractor to come to a unified understanding of the GBR and how it would be followed and how the recording of time and materials was to be done, in the event obstructions were encountered. The Contractor elected to use a 66-inch OD Akkerman WM66SC TBM. Figure 4 is a picture of the face of the machine, prior to launch, showing the cutterhead.
