Nashville, TN
March 11-15, 2012

Paper D-1-03

CONSTRUCTING TWIN 24 INCH FORCE MAINS IN A HIGHLY SENSITIVE ENVIRONMENT UTILIZING HDD

ABSTRACT: In January 2009, Clean Water Services (CWS) began design of the Dawson Creek Pump Station and Force Main project. The project includes a 25 MGD pump station and 15,000 lf of dual 24” force main. To reduce overall force main length, construction costs, environmental impacts, and permitting requirements, the alignment included approximately 1,900 lf installed by HDD in two bores. The bores were vertically stacked and designed with 40-ft of separation and passed under wetlands and Rock Creek. The entry was located on an existing county road and the exit was located in a narrow cul-de-sac in a residential neighborhood. Creative pipe fusing, lay down and staging was required to facilitate construction within the narrow ROW while maintaining access by local residents. The roadway geometry limited the length of pipe strings requiring a multiple fuse approach. Conductor casings were driven at the entry location.

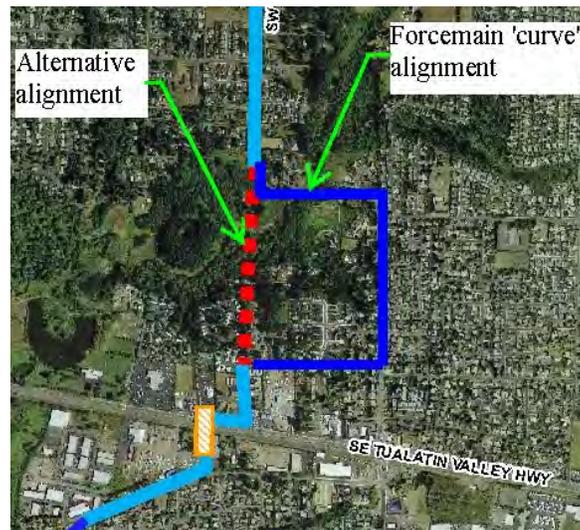
Figure 2. Reduced length alignment alternative

Of the approximately 15,000 lf of twin 24-in force main in the project, 8000 lf was scheduled to be constructed as part of a Washington County road widening project. This section of the alignment included one crossing of Dawson Creek in a section of back to back 90 degree curves in the road. An alignment analysis indicated that by deviating from the roadway alignment at the curves the force main alignment could be reduced by approximately 2500 lf. See Figure 2. However, this reduced length alignment required extensive wetland impacts and a creek crossing. To reduce environmental impact, disturbance and restoration and minimize environmental permitting requirements, trenchless alternatives were considered. After considering geotechnical data, alignment constraints and available technologies it was determined HDD was the most favorable trenchless alternative for the pipe installation.

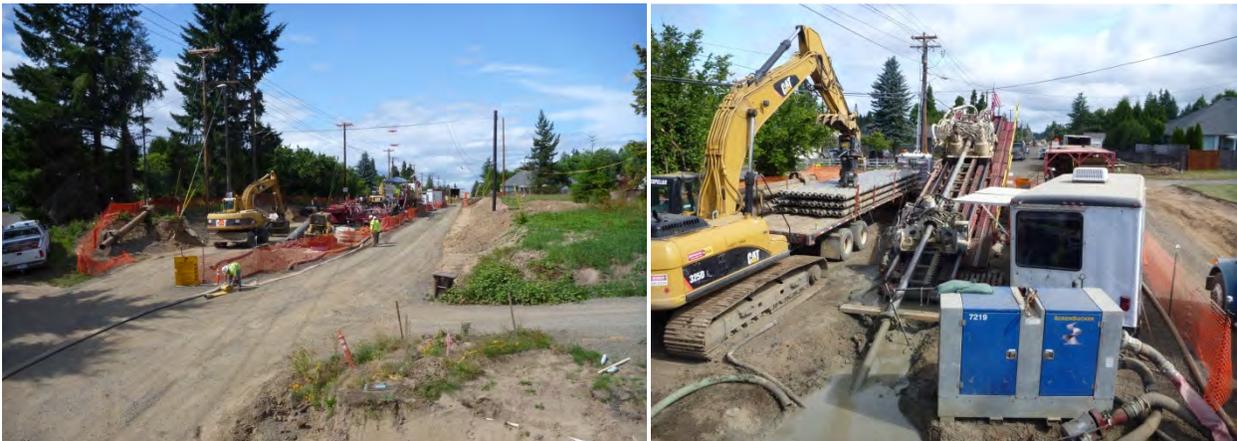
Figure 5. Narrow Entry Site Work Area

The layout room at the entry and the exit for the bores was very constrained. Figure 5 shows the drill rig set up in a linear fashion to allow keeping one lane of the roadway open to traffic during construction. To setup the drilling equipment at the entry site, the contractor elected to survey points prior to mobilization and carefully plan equipment arrival and sequence the mobilization of the equipment to fit all of the necessary equipment in the long but narrow work area that also included overhead power. It should also be noted that this task was performed while maintaining access to the various driveways and through-traffic via a single lane adjacent to the work site. Careful planning of the rig-side layout and set-up allowed savings of both time and resources since the Contractor was able to quickly remobilize to setup for the second bore.

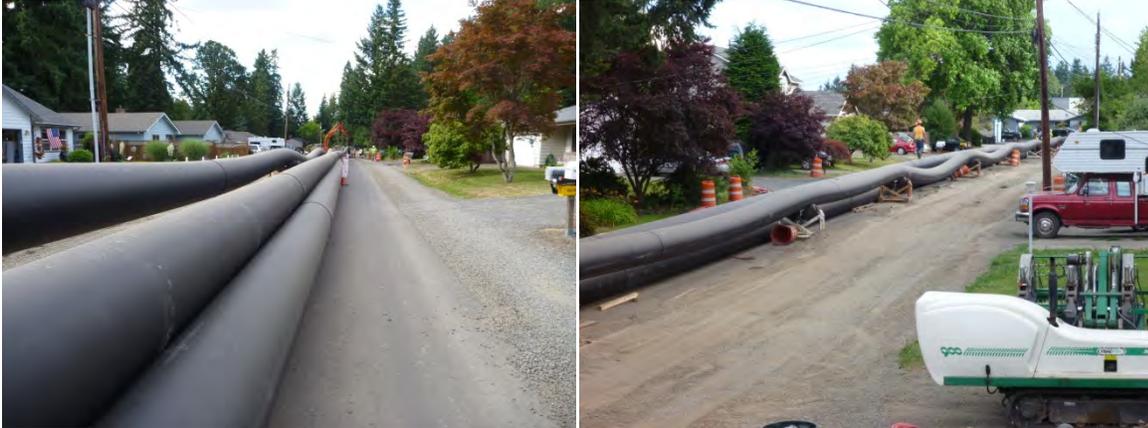
Figure 6. 24-inch HDPE Pipe Layout Along Center of Roadway

To eliminate the need to stop pull-back to fuse 500-foot strings of pipe together, and allow a leak test of the full length of pipe, the design included a layout and traffic control plan that included a 90 degree bend in the staged pipe. Calculations indicated the allowable short term bend radius of 24-in HDPE DR11 pipe would allow the pipe to extend down the cul-de-sac and bend 90 degrees allowing the full length of pipe to be staged for testing. However, the amount of force required to bend the pipe around the 90 degree corner was significant and would have required driving piles or other means to constrain the pipe and prevent potentially serious damage to the pipe, surrounding homes or existing trees. This design scenario required a short term road closure and 24-hr traffic control from the time the pipe was staged in the roadway until pull-back was complete. It also required temporary road widening for the full 1900 lf of staged pipe to maintain local traffic access. Although this alternative was included in the plans to meet the design constraints it was assumed that the contractor would propose alternative methods pipe layout, including possibly negotiating with local land owners for temporary use. During construction, the contractor proposed a revised layout, eliminating the 90 degree bend in the pipe, reducing the temporary widening required thereby reducing neighborhood impacts to residents and resulting in cost savings to both the Owner and the Contractor.

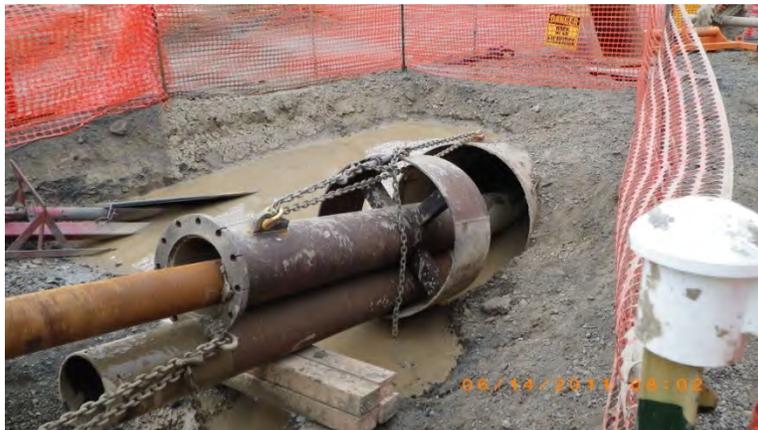
Figure 7 Centralizers Inserted into the Conductor Casing

The Contractor utilized a system of bolt-together centralizer casings as shown in Figure 7 that were inserted into the entry conductor casing to center the alignment during the pilot bore and provide support for the drill pipe during reaming.
