Chicago, Illinois
May 2-7, 2010

Paper A-1-04

OCEAN OUTFALL PRESENTS CHALLENGES TO HDD CONSTRUCTION

Laura Wetter, G.I.T.¹, Matt Pease, P.E.¹, Kristine McCaffrey, P.E.², and Donald R. Kendall, Ph.D., P.E.²

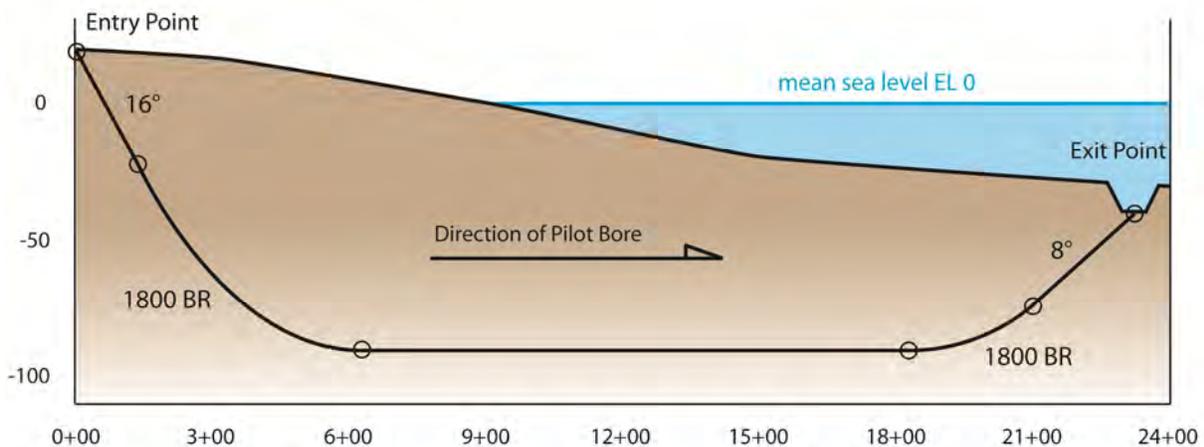
Figure 2. Design bore alignment for the HDD portion of the outfall

The outfall is made up of two segments: approximately 2,300 feet of 36-inch high density polyethylene (HDPE) installed via horizontal directional drilling, and approximately 2,700 feet of 30-inch steel pipe laid out on the seafloor. The design bore alignment for the HDD segment is shown in Figure 2.

The bore begins in the parking lot of the Port Hueneme Beach Park, with a straight, tangent section inclined at 16 degrees for the first 140 linear feet. Curving downward with a bend radius of 1800 feet, the bore reaches a maximum depth of 91 feet below sea level (bsl). After completing a straight section of approximately 1200 feet, the bore bends up to a tangent section of 8 degrees, exiting at 40 feet bsl. Ground elevation at the exit location is approximately 30 feet bsl, requiring excavation of an exit pit via sea floor dredging.

slow significantly at the start of DP #33. At this point the drill bit was at approximate STA 11+00, within the straight horizontal section of the alignment (Figure 2). After tripping three pipes and drilling with little to no returns, the Contractor decided to run a second drill pipe (a “washover” pipe) in along the pilot bore pipe inside the 18-inch centralizer casing. The theory was that a blockage at the end of the casing was preventing the circulation. After inserting the washover pipe down bore approximately 150 feet and retracting, re-drilling began with DP #29. Slurry returns continued to be intermittent, and while the beach was closely monitored for hydrofracture, no signs were found. After drilling up to DP #34 – at which point mud circulation had completely stopped – the Contractor elected to trip out to DP #18 and re-drill. Circulation was re-established and drilling continued smoothly until DP #33 at which time returns slowed noticeably. The Contractor continued drilling with intermittent returns all the way through DP #68.

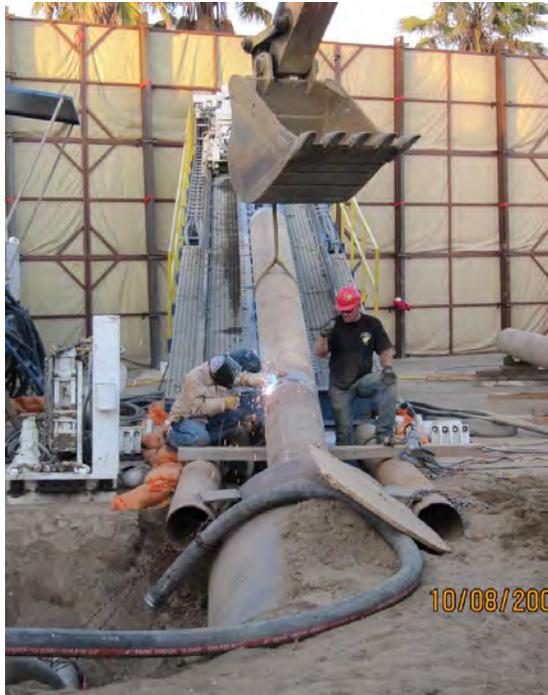
Figure 3. 18-inch centralizer casing installed in larger 54-inch casing

After installation and clean out of the 54-inch conductor casing, an 18-inch steel casing with centralizer pads welded on was inserted the entire length of the 54-inch casing plus an additional 17 feet in preparation for the pilot bore (Figure 3). TruTracker coil was laid out along the onshore portion of the alignment in a shallow hand dug trench above the centerline of the bore. A second TruTracker coil was placed on the ocean floor from the exit point extending 500 feet toward the shore, held in place by concrete ecology blocks set 50 feet apart.

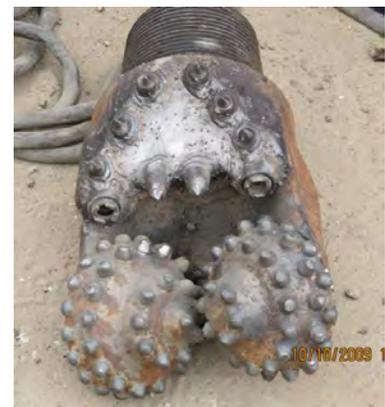
Figure 4. Tri-cone spud bit

The pilot bore began on October 10th, using a 9^{7/8}-inch tri-cone spud bit (Figure 4). A tensor steering tool located behind the bent sub in the borehole assembly was used to track the progress of the pilot hole. Changes in azimuth and inclination were monitored as drilling progressed, allowing the drill rig operator to make directional changes as needed. After the third drill pipe, groundwater was observed coming up out of the 54-inch casing along with the drilling mud, which had slowed noticeably in circulation. No signs of hydrofracture appeared however, and drilling progressed smoothly after an increase in mud speed. Drilling continued until drill pipe (DP) #32 with consistent slurry returns.

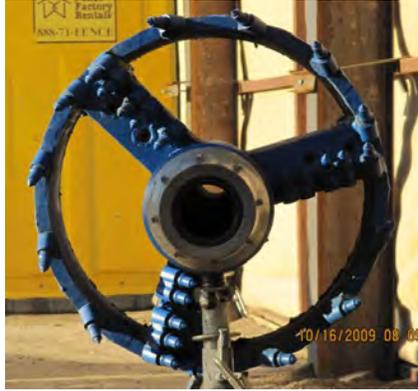
Figure 5. 27-inch fly cutter

The first reaming pass began on October 16th with a 27-inch fly cutter. Prior to starting, the entire drill string was tripped back to the entry point and the borehole assembly and 18-inch centralizer casing removed from the 54-inch casing. The face of the fly cutter is shown in Figure 5. Forward reaming progressed with consistent slurry returns which grew in size and cohesion as distance increased. At this point in time the borehole had not yet exited onto the ocean floor in an attempt to keep slurry returns and cuttings flowing back to the entry point where they could be cleaned and re-circulated instead of discharging into the ocean. Forward reaming was intended to promote this process and keep all mud processing and containment facilities onshore.

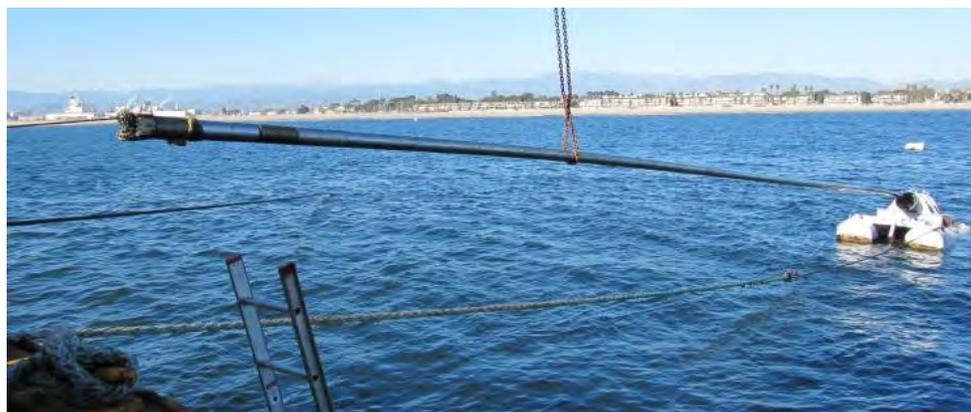
Figure 7. Drill string suspended between derrick barge and pontoon

The drill string exited into the dredged trench and was maneuvered by divers up out of the water and onto a pontoon boat anchored alongside the barge. The pontoon was used to support the midsection of the span as the drill string was pulled toward the barge. The driller began advancing the drill string a little bit at a time while the derrick crane slowly pulled up on the drill bit and the winch on the deck pulled the pipe toward the barge (Figure 7).

Initially the drill bit was exiting the water at about a 30 degree angle, which was too steep to secure to the deck without damage to the pipe. The crew was able to reposition the rigging supporting the drill string farther back down the pipe to

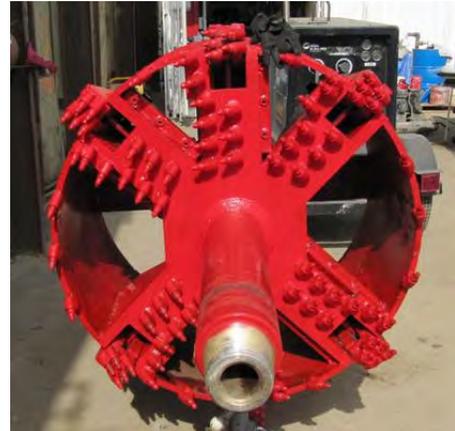
Figure 8. 45-inch reamer with expanding teeth

A 45-inch fly cutter with 2.5-inch hydraulically expanding cutting teeth (shown in Figure 8) was used for the second reaming pass which began on October 27th. With teeth fully extended the 50-inch reamer (size with teeth expanded) was installed at the drill rig and forward reamed using the barge winch to pull on the drill string while the rig applied torque to rotate the reamer. However, the expanded teeth were damaged upon reaching the end of the 54-inch conductor casing. While pumping mud at low pressure and carefully monitoring for signs of settlement, the Contractor began rotating the reamer in an attempt to mill out the end of the 54-inch casing. The drill string had some problems with rotation but managed to get past the casing. No signs of settlement were observed.

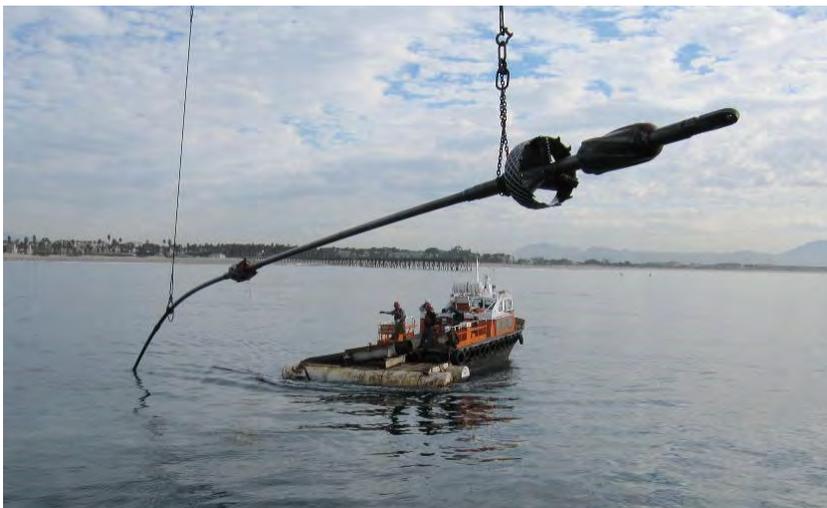
Figure 9. 48-inch reaming assembly exiting to the derrick barge

complete and the reamer was tripped back to the barge (Figure 9).

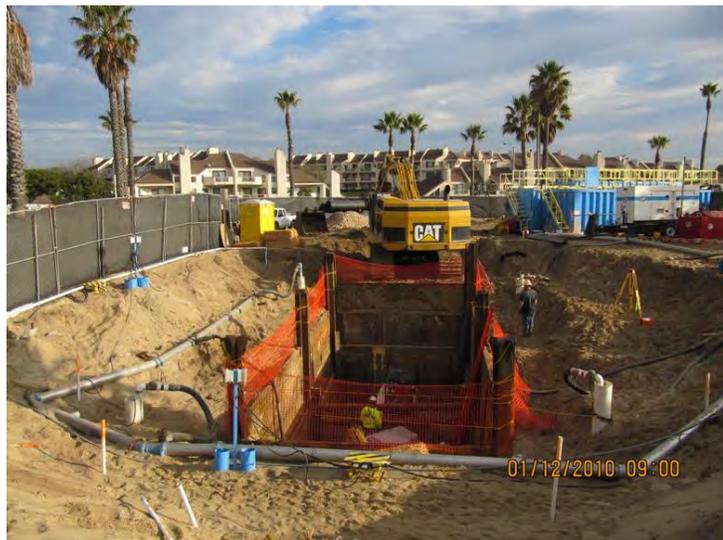
Figure 11. Excavation to expose pull head

After considerable discussion with the Owner, the Contractor exposed the pull head and swivel inside a slide rail shoring excavation at the end of the conductor casing (Figure 11).

However, once the pull head was exposed it was discovered that the pipe was too far out of alignment to be connected within the excavation at the end of the conductor casing. The last 90 feet of 36-inch diameter HDPE product pipe was eventually installed via open cut in February of 2010.
