# Construction Method: Pipe Ramming

**Project:** Fairwood Emergency Culvert Repair

**Location:** Fairwood, Washington

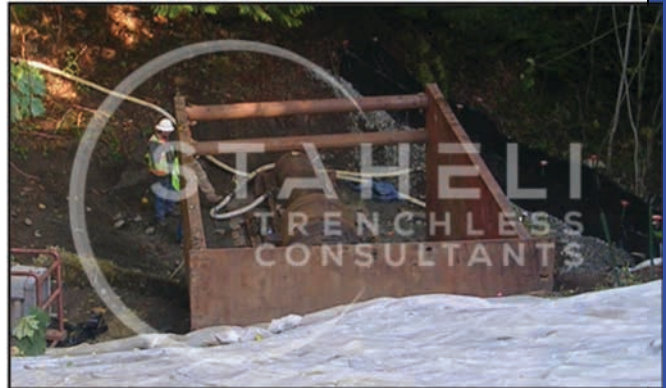
After performing a risk evaluation for King County, it was determined that pipe ramming offered the lowest risk-cost-impact solution for the construction of the new pipeline. STC designed a 48-inch steel casing that was installed by pipe ramming around the existing 36-inch corrugated metal pipe. The corrugated metal pipeline was then removed from within the new pipe. During construction, the contractor elected to use a hydraulic assist with the pneumatic hammer to dramatically increase the ramming speed. This resulted in less rebound of the hammer and substantially increased ramming rates.
